Access Compliance Report

Public Rights-of-Way

(Curb Ramps)

Intersection ID: 47610	Main Street: BATHURST_DR	Cross Street: MINTWORTH_AV	Location: SE
ADA ID: 78D3CC70801F	Ramp Type: BlendTrans1	Initial Pass/Fail: Fail	Overall Compliance: No
Severity Score: 10			
Codes/Mitigation Info/Possible Solution		Field Measurements/Component Compliance

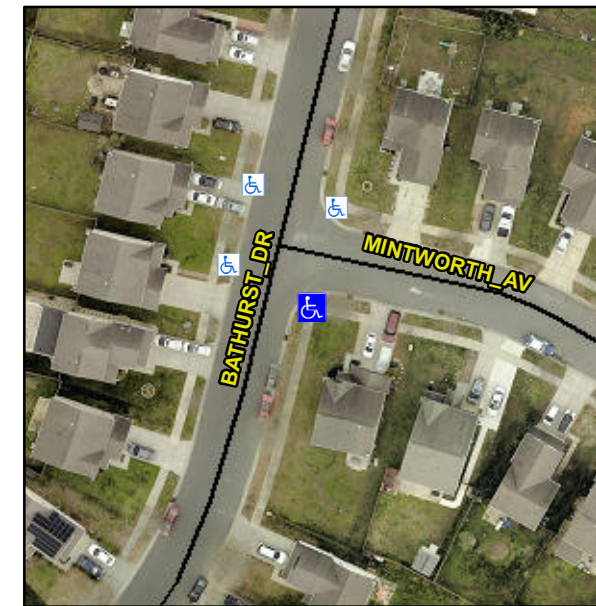
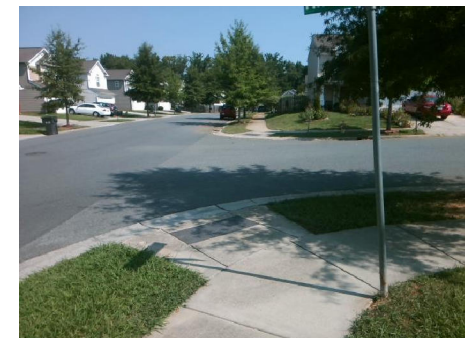
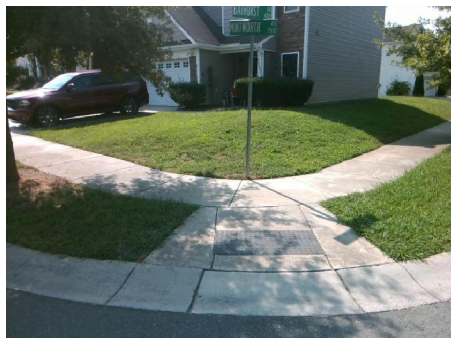
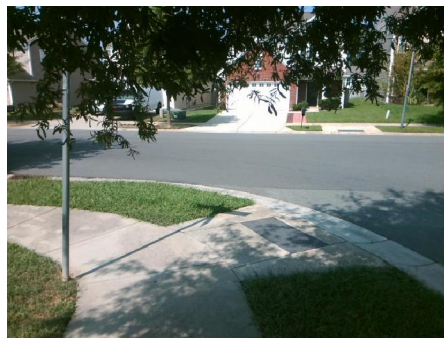
Not Found, R304.5.1, R304.5.3

Compliance	Description	Data	Compliance	Description	Data
N/A	Ramp Length (in)	68.0	Yes	BlendTrans Slope (%)	3.8
No	Ramp Width (in)	47.0	No	BlendTrans XSlope (%)	3.0
N/A	Flare Type LT	N/A	N/A	Flare Type RT	N/A
N/A	Flare Slope LT (%)	N/A	N/A	Flare Slope RT (%)	N/A
N/A	Flare Traversable LT?	N/A	N/A	Flare Traversable RT?	N/A
N/A	Landing Length (in)	N/A	N/A	DWS Provided?	N/A
N/A	Landing Width (in)	N/A	N/A	DWS Contrast?	N/A
N/A	Landing Slope (%)	N/A	N/A	DWS Length (in)	N/A
N/A	Landing X Slope (%)	N/A	N/A	DWS Full Width?	N/A
N/A	Landing Curb? (Y/N)	N/A	N/A	DWS Offset (in)	N/A
N/A	Shared Landing?	N/A			
N/A	Gutter Ponding?	N/A	N/A	Gutter Slope (%)	N/A
N/A	Gutter Lip Ht (in)	N/A	N/A	Gutter X Slope (%)	N/A
N/A	Painted X Walk1?	No	N/A	Painted X Walk2?	No
	X Walk 1 Direction	To NE		X Walk 2 Direction	To NW
	X Walk 1 Width (in)	N/A		X Walk 2 Width (in)	N/A
	X Walk 1 Slope (%)	2.3		X Walk 2 Slope (%)	1.9
	X Walk 1 X Slope (%)	0.8		X Walk 2 X Slope (%)	1.2

N/A	Ramp inside XWalk1?	N/A	N/A	Ramp inside XWalk2?	N/A
	Road Slope (%)	1.7		Clear Space?	N/A
	Road X Slope (%)	0.9	N/A	Clear Space to XWalk (in)	N/A
N/A	Any Obstructions?	N/A	N/A	Storm Grate/Utility Hazard?	N/A
	Obstruction Type			Storm Grate/Utility Type	
		N/A			N/A
			Yes	Surface Condition? (G/P)	Good
			No	Curb Slope (%)	16.6

Remove & Replace Curb Ramp With Two New Directional Ramps or Equivalent.
