# Access Compliance Report

## Public Rights-of-Way

### (Curb Ramps)

Intersection ID: 28944	Main Street: ROLAND_ST	Cross Street: LOGIE_AV	Location: NW
ADA ID: 78EEA3A39E4D	Ramp Type: Perp	Initial Pass/Fail: Fail	Overall Compliance: No
		Severity Score: 10

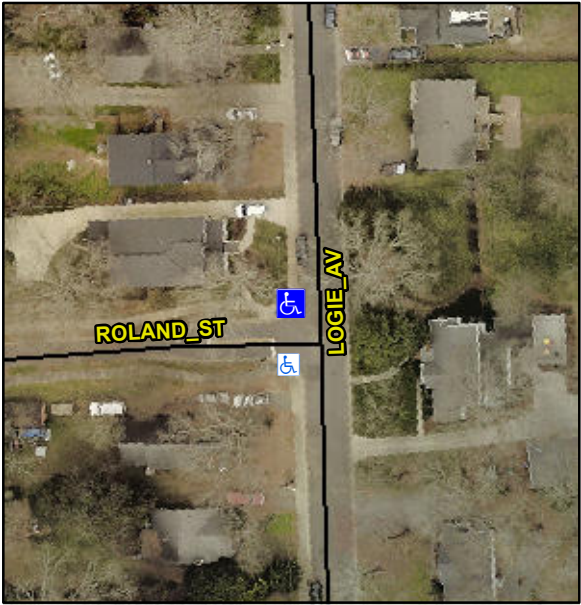
Possible Solutions:		<b>Compliance</b>	<b>Description</b>	<b>Data</b>	
	<b>Remove &amp; Replace Entire Ramp.</b>		<b>N/A</b>	Ramp Length (in)	<b>70.0</b>	<b>Yes</b>
			<b>No</b>	Ramp Width (in)	<b>47.0</b>	<b>No</b>
			<b>N/A</b>	Flare Type LT	<b>N/A</b>	<b>N/A</b>
			<b>N/A</b>	Flare Slope LT (%)	<b>N/A</b>	<b>N/A</b>
			<b>N/A</b>	Flare Traversable LT?	<b>N/A</b>	<b>N/A</b>
			<b>N/A</b>	Landing Length (in)	<b>N/A</b>	<b>N/A</b>
			<b>N/A</b>	Landing Width (in)	<b>N/A</b>	<b>N/A</b>
			<b>N/A</b>	Landing Slope (%)	<b>N/A</b>	<b>N/A</b>
			<b>N/A</b>	Landing X Slope (%)	<b>N/A</b>	<b>N/A</b>
			<b>N/A</b>	Landing Curb? (Y/N)	<b>N/A</b>	<b>N/A</b>
			<b>N/A</b>	Shared Landing?	<b>N/A</b>	
			<b>N/A</b>	Gutter Ponding?	<b>N/A</b>	<b>N/A</b>
			<b>N/A</b>	Gutter Lip Ht (in)	<b>N/A</b>	<b>N/A</b>
			<b>N/A</b>	Painted X Walk1?	<b>No</b>	<b>N/A</b>

X Walk 1 Direction	<b>To S</b>	<b>N/A</b>
			<b>N/A</b>	X Walk 1 Width (in)	<b>N/A</b>	<b>N/A</b>
				X Walk 1 Slope (%)	<b>4.2</b>	<b>N/A</b>
				X Walk 1 X Slope (%)	<b>4.3</b>	<b>N/A</b>
			<b>N/A</b>	Ramp inside XWalk1?	<b>N/A</b>	<b>N/A</b>
<p>Surveyor Notes:</p> <p><b>N/A</b></p> <p>PROW/ADA:</p> <p><b>Not Found, R304.5.1, R304.5.3</b></p>			<b>N/A</b>	Road Slope (%)	<b>N/A</b>	<b>N/A</b>
			<b>N/A</b>	Road X Slope (%)	<b>N/A</b>	<b>N/A</b>
			<b>N/A</b>	Any Obstructions?	<b>N/A</b>	<b>N/A</b>
				Obstruction Type		
					<b>N/A</b>	<b>N/A</b>
			<b>Yes</b>	Surface Condition? (G/P)	<b>Good</b>	
Total Cost:		\$ 1850.00
