# Access Compliance Report

## Public Rights-of-Way

### (Curb Ramps)

Intersection ID: 49250	Main Street: RIDGE_PATH_LN	Cross Street: BOOMERANG_WY	Location: W
ADA ID: 78F38CBDF0E6	Ramp Type: BlendTrans1	Initial Pass/Fail: Fail	Overall Compliance: No
Severity Score: 8.75			
Codes/Mitigation Info/Possible Solution		Field Measurements/Component Compliance

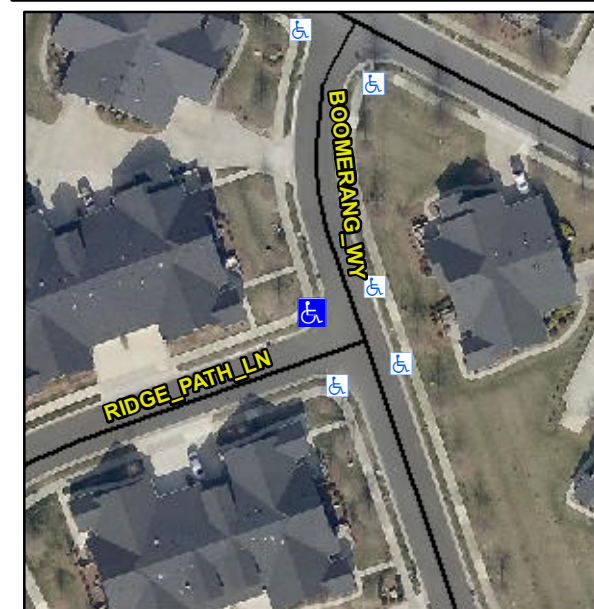
**LNDG LIP 0.5**

**Not Found, R304.5.1**

**Remove & Replace Curb Ramp With Two New Directional Ramps or Equivalent.**

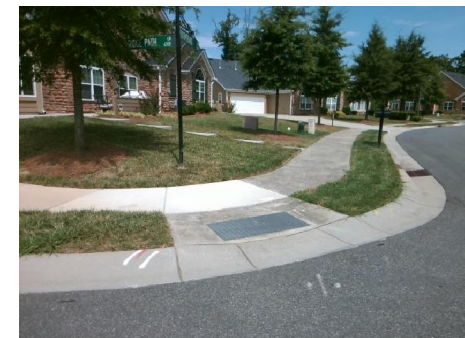
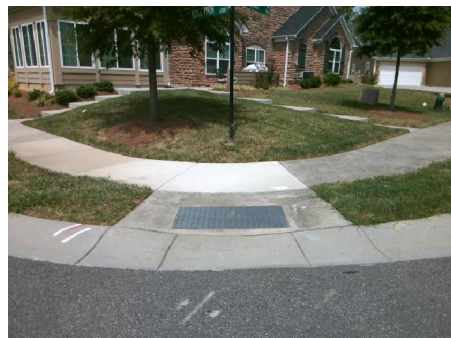
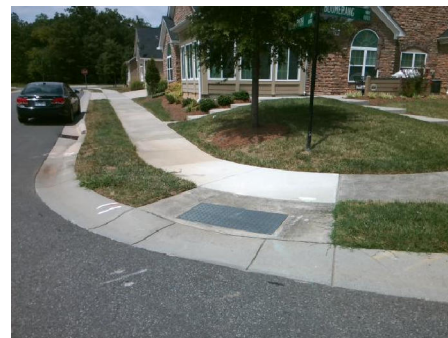
Compliance	Description	Data	Compliance	Description	Data
N/A	Ramp Length (in)	49.0	Yes	BlendTrans Slope (%)	3.1
No	Ramp Width (in)	45.0	Yes	BlendTrans XSlope (%)	1.8
N/A	Flare Type LT	N/A	N/A	Flare Type RT	N/A
N/A	Flare Slope LT (%)	N/A	N/A	Flare Slope RT (%)	N/A
N/A	Flare Traversable LT?	N/A	N/A	Flare Traversable RT?	N/A
N/A	Landing Length (in)	N/A	N/A	DWS Provided?	N/A
N/A	Landing Width (in)	N/A	N/A	DWS Contrast?	N/A
N/A	Landing Slope (%)	N/A	N/A	DWS Length (in)	N/A
N/A	Landing X Slope (%)	N/A	N/A	DWS Full Width?	N/A
N/A	Landing Curb? (Y/N)	N/A	N/A	DWS Offset (in)	N/A
N/A	Shared Landing?	N/A			
N/A	Gutter Ponding?	N/A	N/A	Gutter Slope (%)	N/A
N/A	Gutter Lip Ht (in)	0.5	N/A	Gutter X Slope (%)	N/A
N/A	Painted X Walk1?	No	N/A	Painted X Walk2?	No
	X Walk 1 Direction	To SE		X Walk 2 Direction	To NE
	X Walk 1 Width (in)	N/A		X Walk 2 Width (in)	N/A
	X Walk 1 Slope (%)	0.9		X Walk 2 Slope (%)	0.7
	X Walk 1 X Slope (%)	0.0		X Walk 2 X Slope (%)	0.9

N/A	Ramp inside XWalk1?	N/A	N/A	Ramp inside XWalk2?	N/A
	Road Slope (%)	1.8		Clear Space?	N/A
	Road X Slope (%)	0.1	N/A	Clear Space to XWalk (in)	N/A
N/A	Any Obstructions?	N/A	N/A	Storm Grate/Utility Hazard?	N/A
	Obstruction Type			Storm Grate/Utility Type	
		N/A			N/A
			Yes	Surface Condition? (G/P)	Good
			No	Curb Slope (%)	13.3
