# Access Compliance Report

## Public Rights-of-Way

### (Curb Ramps)

Intersection ID: 2874	Main Street: HORNBEAM_CT	Cross Street: LADY_BANK_DR	Location: NE
ADA ID: 78F81CC67E9B	Ramp Type: Perp	Initial Pass/Fail: Fail	Overall Compliance: No
Severity Score: 46.25			
Codes/Mitigation Info/Possible Solution		Field Measurements/Component Compliance

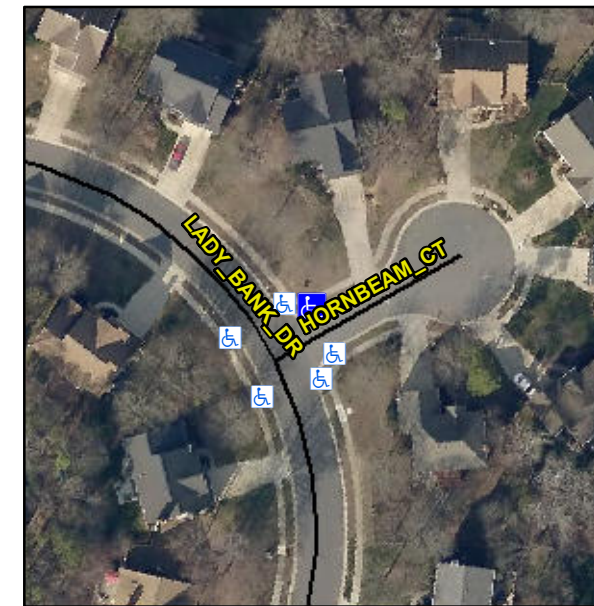
Compliance	Description	Data	Compliance	Description	Data
N/A	Ramp Length (in)	50.0	No	Ramp Slope (%)	15.4
No	Ramp Width (in)	37.0	No	Ramp XSlope (%)	5.5
N/A	Flare Type LT	N/A	N/A	Flare Type RT	N/A
N/A	Flare Slope LT (%)	N/A	N/A	Flare Slope RT (%)	N/A
N/A	Flare Traversable LT?	N/A	N/A	Flare Traversable RT?	N/A
N/A	Landing Length (in)	N/A	N/A	DWS Provided?	N/A
N/A	Landing Width (in)	N/A	N/A	DWS Contrast?	N/A
N/A	Landing Slope (%)	N/A	N/A	DWS Length (in)	N/A
N/A	Landing X Slope (%)	N/A	N/A	DWS Full Width?	N/A
N/A	Landing Curb? (Y/N)	N/A	N/A	DWS Offset (in)	N/A
N/A	Shared Landing?	N/A			
N/A	Gutter Ponding?	N/A	N/A	Gutter Slope (%)	N/A
N/A	Gutter Lip Ht (in)	N/A	N/A	Gutter X Slope (%)	N/A
N/A	Painted X Walk1?	No	N/A	Painted X Walk2?	N/A
	X Walk 1 Direction	To S		X Walk 2 Direction	N/A
N/A	X Walk 1 Width (in)	N/A	N/A	X Walk 2 Width (in)	N/A
	X Walk 1 Slope (%)	1.8		X Walk 2 Slope (%)	N/A
	X Walk 1 X Slope (%)	5.3		X Walk 2 X Slope (%)	N/A

N/A	Ramp inside XWalk1?	N/A	N/A	Ramp inside XWalk2?	N/A
	Road Slope (%)	N/A	N/A	Clear Space?	N/A
	Road X Slope (%)	N/A	N/A	Clear Space to XWalk (in)	N/A
N/A	Any Obstructions?	N/A	N/A	Storm Grate/Utility Hazard?	N/A
	Obstruction Type			Storm Grate/Utility Type	
		N/A			N/A
			Yes	Surface Condition? (G/P)	Good

**Remove & Replace Entire Ramp.**

**R304.5.1, R304.2.2, R304.5.3**
