Access Compliance Report

Public Rights-of-Way

(Curb Ramps)

| Intersection ID: 13912 | Main Street: KENILWORTH_AV | Cross Street: E_JOHN_BELK_RA | Location: SW |

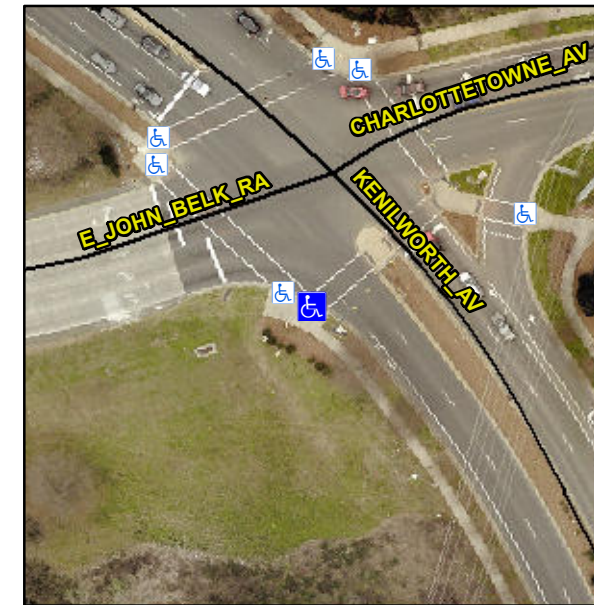
| ADA ID: 790CDEF2E135 | Ramp Type: Perp | Initial Pass/Fail: Fail | Overall Compliance: No Severity Score: 13.75 |

Not Found, R304.2.2, R304.5.3

| Compliance | Description | Data | Compliance | Description | Data |
|---|---|---|---|---|---|
| N/A | Ramp Length (in) | 48.0 | No | Ramp Slope (%) | 9.6 |
| Yes | Ramp Width (in) | 48.0 | No | Ramp XSlope (%) | 2.9 |

Remove & Replace Entire Ramp.
