Access Compliance Report

Public Rights-of-Way

(Curb Ramps)

Intersection ID: 15624	Main Street: ORDERMORE_AV	Cross Street: SCOTT_AV	Location: S
ADA ID: 790D5F684CB7	Ramp Type: PerpDiag	Initial Pass/Fail: Fail	Overall Compliance: No
		Severity Score: 12.5

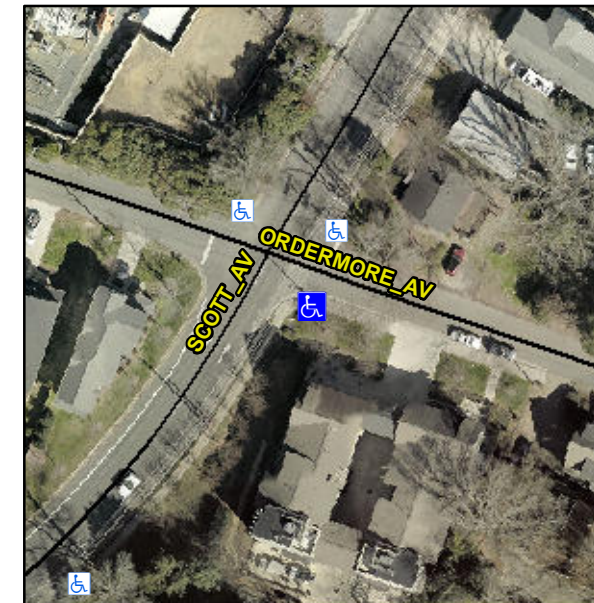
Not Found, R304.2.2

Compliance	Description	Data	Compliance	Description	Data
N/A	Ramp Length (in)	70.0	No	Ramp Slope (%)	8.5
Yes	Ramp Width (in)	48.0	Yes	Ramp XSlope (%)	2.0
N/A	Flare Type LT	N/A	N/A	Flare Type RT	N/A
N/A	Flare Slope LT (%)	N/A	N/A	Flare Slope RT (%)	N/A
N/A	Flare Traversable LT?	N/A	N/A	Flare Traversable RT?	N/A
N/A	Landing Length (in)	N/A	N/A	DWS Provided?	N/A
N/A	Landing Width (in)	N/A	N/A	DWS Contrast?	N/A
N/A	Landing Slope (%)	N/A	N/A	DWS Length (in)	N/A
N/A	Landing X Slope (%)	N/A	N/A	DWS Full Width?	N/A
N/A	Landing Curb? (Y/N)	N/A	N/A	DWS Offset (in)	N/A
N/A	Shared Landing?	N/A			
N/A	Gutter Ponding?	N/A	N/A	Gutter Slope (%)	N/A
N/A	Gutter Lip Ht (in)	N/A	N/A	Gutter X Slope (%)	N/A
N/A	Painted X Walk1?	No	N/A	Painted X Walk2?	No
	X Walk 1 Direction	To NE		X Walk 2 Direction	To NW
N/A	X Walk 1 Width (in)	N/A	N/A	X Walk 2 Width (in)	N/A
	X Walk 1 Slope (%)	3.9		X Walk 2 Slope (%)	1.2
	X Walk 1 X Slope (%)	4.4		X Walk 2 X Slope (%)	2.6

N/A	Ramp inside XWalk1?	N/A	N/A	Ramp inside XWalk2?	N/A
	Road Slope (%)	3.0	N/A	Clear Space?	N/A
	Road X Slope (%)	4.5	N/A	Clear Space to XWalk (in)	N/A
N/A	Any Obstructions?	N/A	N/A	Storm Grate/Utility Hazard?	N/A
	Obstruction Type			Storm Grate/Utility Type	
		N/A			N/A
			Yes	Surface Condition? (G/P)	Good

Remove & Replace Curb Ramp With Two New Directional Ramps or Equivalent.
