Access Compliance Report Public Rights-of-Way (Curb Ramps)

Intersection ID: 10067Main Street:ETHEL_GUEST_LNCross Street:OAKLAWN_AVLocation:NEADA ID: 79105C340004Ramp Type:PerpDiagInitial Pass/Fail:FailOverall Compliance:NoSeverity Score:13.75

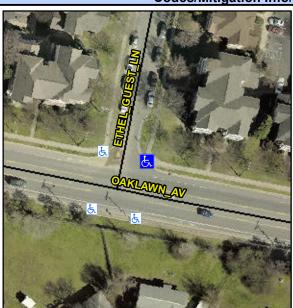
Not Found, R304.2.2, R304.5.3

Field Measurements/Component Compliance					
Compliance Description		Data	Com	oliance Description	Data
N/	A Ramp Length (in)	48.0	No	Ramp Slope (%)	10.9
Ye	s Ramp Width (in)	53.0	No	Ramp XSlope (%)	4.2
N/A	A Flare Type LT	N/A	N/A	Flare Type RT	N/A
N/	A Flare Slope LT (%)	N/A	N/A	Flare Slope RT (%)	N/A
N/	A Flare Traversable LT?	N/A	N/A	Flare Traversable RT?	N/A
N/	A Landing Length (in)	N/A	N/A	DWS Provided?	N/A
N/	A Landing Width (in)	N/A	N/A	DWS Contrast?	N/A
N/	A Landing Slope (%)	N/A	N/A	DWS Length (in)	N/A
N/	A Landing X Slope (%)	N/A	N/A	DWS Full Width?	N/A
N/	A Landing Curb? (Y/N)	N/A	N/A	DWS Offset (in)	N/A
N/	A Shared Landing?	N/A			
N/	A Gutter Ponding?	N/A	N/A	Gutter Slope (%)	N/A
N/A	A Gutter Lip Ht (in)	N/A	N/A	Gutter X Slope (%)	N/A
N/	A Painted X Walk1?	No	N/A	Painted X Walk2?	No
	X Walk 1 Direction	To NW		X Walk 2 Direction	To SW
N/	A X Walk 1 Width (in)	N/A	N/A	X Walk 2 Width (in)	N/A
	X Walk 1 Slope (%)	3.4		X Walk 2 Slope (%)	2.7

X Walk 1 X Slope (%)	3.9		X Walk 2 X Slope (%)	2.1
N/	A Ramp inside XWalk1?	N/A	N/A	Ramp inside XWalk2?	N/A
	Road Slope (%)	3.2	N/A	Clear Space?	N/A
	Road X Slope (%)	1.7	N/A	Clear Space to XWalk (in)	N/A
N/	A Any Obstructions?	N/A	N/A	Storm Grate/Utility Hazard?	N/A
	Obstruction Type			Storm Grate/Utility Type	
		N/A			N/A
			Yes	Surface Condition? (G/P)	Good
Particular C	10

Remove & Replace Curb Ramp With Two New Directional Ramps or Equivalent.
