Access Compliance Report

Public Rights-of-Way

(Curb Ramps)

Intersection ID: 14311	Main Street: BERKELEY_AV	Cross Street: CARLTON_AV	Location: SW
ADA ID: 7912F253C69A	Ramp Type: Perp	Initial Pass/Fail: Fail	Overall Compliance: No
Severity Score: 12.5			
Codes/Mitigation Info/Possible Solution		Field Measurements/Component Compliance

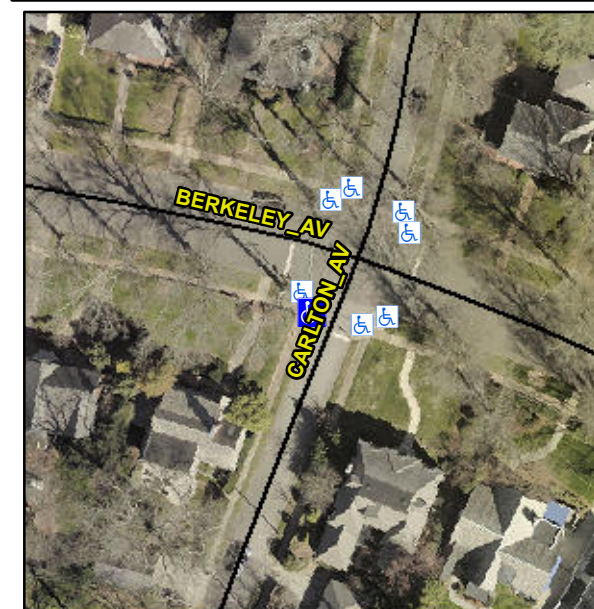
Not Found, R304.2.2

Compliance	Description	Data	Compliance	Description	Data
N/A	Ramp Length (in)	62.0	No	Ramp Slope (%)	8.5
Yes	Ramp Width (in)	60.0	Yes	Ramp XSlope (%)	0.9
N/A	Flare Type LT	N/A	N/A	Flare Type RT	N/A
N/A	Flare Slope LT (%)	N/A	N/A	Flare Slope RT (%)	N/A
N/A	Flare Traversable LT?	N/A	N/A	Flare Traversable RT?	N/A
N/A	Landing Length (in)	N/A	N/A	DWS Provided?	N/A
N/A	Landing Width (in)	N/A	N/A	DWS Contrast?	N/A
N/A	Landing Slope (%)	N/A	N/A	DWS Length (in)	N/A
N/A	Landing X Slope (%)	N/A	N/A	DWS Full Width?	N/A
N/A	Landing Curb? (Y/N)	N/A	N/A	DWS Offset (in)	N/A
N/A	Shared Landing?	N/A			
N/A	Gutter Ponding?	N/A	N/A	Gutter Slope (%)	N/A
N/A	Gutter Lip Ht (in)	N/A	N/A	Gutter X Slope (%)	N/A
N/A	Painted X Walk1?	No	N/A	Painted X Walk2?	N/A
	X Walk 1 Direction	To SE		X Walk 2 Direction	N/A
N/A	X Walk 1 Width (in)	N/A	N/A	X Walk 2 Width (in)	N/A
	X Walk 1 Slope (%)	2.0		X Walk 2 Slope (%)	N/A
	X Walk 1 X Slope (%)	3.0		X Walk 2 X Slope (%)	N/A

N/A	Ramp inside XWalk1?	N/A	N/A	Ramp inside XWalk2?	N/A
	Road Slope (%)	N/A	N/A	Clear Space?	N/A
	Road X Slope (%)	N/A	N/A	Clear Space to XWalk (in)	N/A
N/A	Any Obstructions?	N/A	N/A	Storm Grate/Utility Hazard?	N/A
	Obstruction Type			Storm Grate/Utility Type	
		N/A			N/A
			Yes	Surface Condition? (G/P)	Good

Possible Solutions:

Remove & Replace Entire Ramp.
