Access Compliance Report

Public Rights-of-Way

(Curb Ramps)

| Intersection ID: 11683 | Main Street: E_17TH_ST | Cross Street: N_ALEXANDER_ST | Location: E |

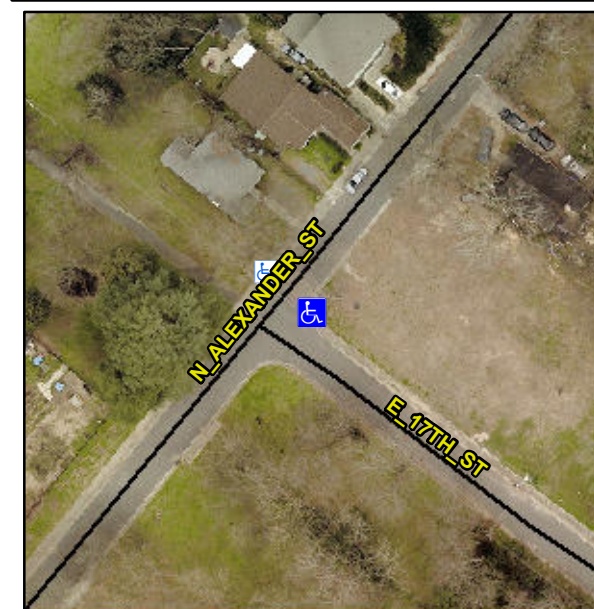
Not Found, R304.5.1, R304.2.2, R304.5.3

| Compliance | Description | Data | Compliance | Description | Data |
|---|---|---|---|---|---|
| N/A | Ramp Length (in) | 58.0 | No | Ramp Slope (%) | 9.6 |
| No | Ramp Width (in) | 36.0 | No | Ramp XSlope (%) | 6.7 |

Remove & Replace Entire Ramp.
