Access Compliance Report Public Rights-of-Way (Curb Ramps)

Intersection ID: 24751 Main Street: CINNAMON_FIELD_RD Cross Street: WILD_HEATHER_CT Location: SW

ADA ID: 791520A1C6F8 Ramp Type: Perp Initial Pass/Fail: Fail Overall Compliance: No Severity Score: 13.75

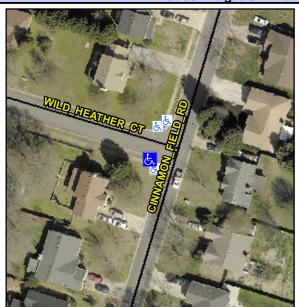
R304.2.2, R304.5.3

Field Measurements/Component Compliance					
Compliance Description		Data	Comp	pliance Description	Data
N/	A Ramp Length (in)	46.0	No	Ramp Slope (%)	8.9
Ye	s Ramp Width (in)	48.0	No	Ramp XSlope (%)	2.8
N/	A Flare Type LT	N/A	N/A	Flare Type RT	N/A
N/	A Flare Slope LT (%)	N/A	N/A	Flare Slope RT (%)	N/A
N/	A Flare Traversable LT?	N/A	N/A	Flare Traversable RT?	N/A
N/	A Landing Length (in)	N/A	N/A	DWS Provided?	N/A
N/	A Landing Width (in)	N/A	N/A	DWS Contrast?	N/A
N/	A Landing Slope (%)	N/A	N/A	DWS Length (in)	N/A
N/	A Landing X Slope (%)	N/A	N/A	DWS Full Width?	N/A
N/	A Landing Curb? (Y/N)	N/A	N/A	DWS Offset (in)	N/A
N/	A Shared Landing?	N/A			
N/	A Gutter Ponding?	N/A	N/A	Gutter Slope (%)	N/A
N/	A Gutter Lip Ht (in)	N/A	N/A	Gutter X Slope (%)	N/A
N/	A Painted X Walk1?	No	N/A	Painted X Walk2?	N/A
	X Walk 1 Direction	To NE		X Walk 2 Direction	N/A
N/	A X Walk 1 Width (in)	N/A	N/A	X Walk 2 Width (in)	N/A
	X Walk 1 Slope (%)	0.9		X Walk 2 Slope (%)	N/A

X Walk 1 X Slope (%)	1.6		X Walk 2 X Slope (%)	N/A
N/	A Ramp inside XWalk1?	N/A	N/A	Ramp inside XWalk2?	N/A
	Road Slope (%)	N/A	N/A	Clear Space?	N/A
	Road X Slope (%)	N/A	N/A	Clear Space to XWalk (in)	N/A
N/	A Any Obstructions?	N/A	N/A	Storm Grate/Utility Hazard?	N/A
	Obstruction Type			Storm Grate/Utility Type	
		N/A			N/A
			Yes	Surface Condition? (G/P)	Good
se si e		'	-	• ,

Remove & Replace Entire Ramp.
