# Access Compliance Report

## Public Rights-of-Way

### (Curb Ramps)

Intersection ID: N/A	Main Street: PROVIDENCE_RD	Cross Street: SOUTHGROVE_ST	Location: SE
ADA ID: 79269CB54EFD	Ramp Type: PerpDiag	Initial Pass/Fail: Fail	Overall Compliance: No
Severity Score: 12.5			
Codes/Mitigation Info/Possible Solution		Field Measurements/Component Compliance

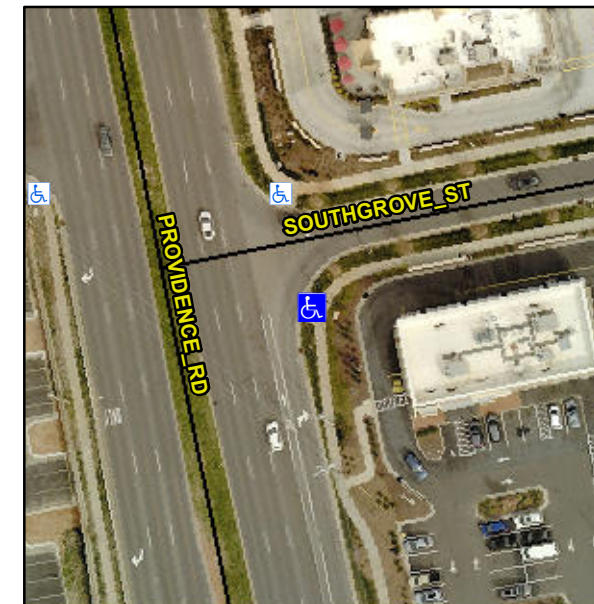
**Not Found, R304.5.3**

Compliance	Description	Data	Compliance	Description	Data
N/A	Ramp Length (in)	96.0	Yes	Ramp Slope (%)	6.5
Yes	Ramp Width (in)	48.0	No	Ramp XSlope (%)	5.6
N/A	Flare Type LT	N/A	N/A	Flare Type RT	N/A
N/A	Flare Slope LT (%)	N/A	N/A	Flare Slope RT (%)	N/A
N/A	Flare Traversable LT?	N/A	N/A	Flare Traversable RT?	N/A
N/A	Landing Length (in)	N/A	N/A	DWS Provided?	N/A
N/A	Landing Width (in)	N/A	N/A	DWS Contrast?	N/A
N/A	Landing Slope (%)	N/A	N/A	DWS Length (in)	N/A
N/A	Landing X Slope (%)	N/A	N/A	DWS Full Width?	N/A
N/A	Landing Curb? (Y/N)	N/A	N/A	DWS Offset (in)	N/A
N/A	Shared Landing?	N/A			
N/A	Gutter Ponding?	N/A	N/A	Gutter Slope (%)	N/A
N/A	Gutter Lip Ht (in)	N/A	N/A	Gutter X Slope (%)	N/A
N/A	Painted X Walk1?	No	N/A	Painted X Walk2?	No
	X Walk 1 Direction	To N		X Walk 2 Direction	To W
N/A	X Walk 1 Width (in)	N/A	N/A	X Walk 2 Width (in)	N/A
	X Walk 1 Slope (%)	1.4		X Walk 2 Slope (%)	5.3
	X Walk 1 X Slope (%)	4.2		X Walk 2 X Slope (%)	4.2

N/A	Ramp inside XWalk1?	N/A	N/A	Ramp inside XWalk2?	N/A
	Road Slope (%)	4.4	N/A	Clear Space?	N/A
	Road X Slope (%)	1.3	N/A	Clear Space to XWalk (in)	N/A
N/A	Any Obstructions?	N/A	N/A	Storm Grate/Utility Hazard?	N/A
	Obstruction Type			Storm Grate/Utility Type	
		N/A			N/A
			Yes	Surface Condition? (G/P)	Good

**Remove & Replace Curb Ramp With Two New Directional Ramps or Equivalent.**
