Access Compliance Report Public Rights-of-Way (Curb Ramps)

Intersection ID: 28373Main Street: ASTOR_HALL_DRCross Street: SOUTHAMPTON_COMMONS_DRLocation:SWADA ID: 79285A3E17BERamp Type: PerpInitial Pass/Fail: FailOverall Compliance: NoSeverity Score: 12.5

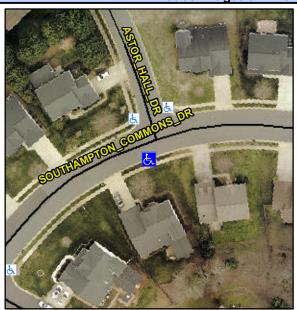
/Possible Solution	Field Measurements/Component Compliance						
Possible Solutions:	Compliance Description		Data	Data Compliance Description		Data	
Remove & Replace Entire Ramp.	N/A	Ramp Length (in)	47.0	Yes	Ramp Slope (%)	6.4	
·	Yes	Ramp Width (in)	48.0	No	Ramp XSlope (%)	5.8	
	N/A	Flare Type LT	N/A	N/A	Flare Type RT	N/A	
	N/A	Flare Slope LT (%)	N/A	N/A	Flare Slope RT (%)	N/A	
	N/A	Flare Traversable LT?	N/A	N/A	Flare Traversable RT?	N/A	
	N/A	Landing Length (in)	N/A	N/A	DWS Provided?	N/A	
Surveyor Notes:	N/A	Landing Width (in)	N/A	N/A	DWS Contrast?	N/A	
N/A	N/A	Landing Slope (%)	N/A	N/A	DWS Length (in)	N/A	
	N/A	Landing X Slope (%)	N/A	N/A	DWS Full Width?	N/A	
	N/A	Landing Curb? (Y/N)	N/A	N/A	DWS Offset (in)	N/A	
	N/A	Shared Landing?	N/A				
PROW/ADA:	N/A	Gutter Ponding?	N/A	N/A	Gutter Slope (%)	N/A	
Not Found, R304.5.3	N/A	Gutter Lip Ht (in)	N/A	N/A	Gutter X Slope (%)	N/A	
ŕ	N/A	Painted X Walk1?	No	N/A	Painted X Walk2?	N/A
