Access Compliance Report

Public Rights-of-Way

(Curb Ramps)

Intersection ID: 47099	Main Street: GALLERIA_BV	Cross Street: N/A	Location: NE
ADA ID: 792BBD4DED39	Ramp Type: Perp	Initial Pass/Fail: Fail	Overall Compliance: No
		Severity Score: 8.75

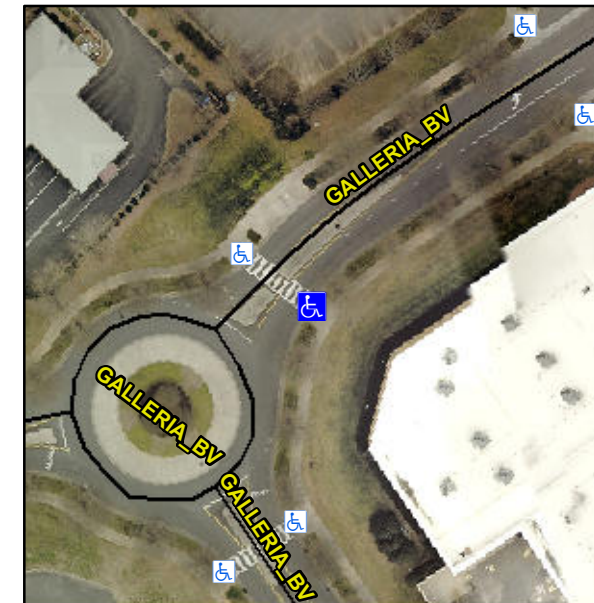
Not Found, R304.5.1

Compliance	Description	Data	Compliance	Description	Data
N/A	Ramp Length (in)	95.5	Yes	Ramp Slope (%)	5.5
No	Ramp Width (in)	43.5	Yes	Ramp XSlope (%)	1.1
N/A	Flare Type LT	N/A	N/A	Flare Type RT	N/A
N/A	Flare Slope LT (%)	N/A	N/A	Flare Slope RT (%)	N/A
N/A	Flare Traversable LT?	N/A	N/A	Flare Traversable RT?	N/A
N/A	Landing Length (in)	N/A	N/A	DWS Provided?	N/A
N/A	Landing Width (in)	N/A	N/A	DWS Contrast?	N/A
N/A	Landing Slope (%)	N/A	N/A	DWS Length (in)	N/A
N/A	Landing X Slope (%)	N/A	N/A	DWS Full Width?	N/A
N/A	Landing Curb? (Y/N)	N/A	N/A	DWS Offset (in)	N/A
N/A	Shared Landing?	N/A			
N/A	Gutter Ponding?	N/A	N/A	Gutter Slope (%)	N/A
N/A	Gutter Lip Ht (in)	N/A	N/A	Gutter X Slope (%)	N/A
N/A	Painted X Walk1?	Yes	N/A	Painted X Walk2?	N/A
	X Walk 1 Direction	To NW		X Walk 2 Direction	N/A
N/A	X Walk 1 Width (in)	111.0	N/A	X Walk 2 Width (in)	N/A
	X Walk 1 Slope (%)	1.2		X Walk 2 Slope (%)	N/A
	X Walk 1 X Slope (%)	1.6		X Walk 2 X Slope (%)	N/A

N/A	Ramp inside XWalk1?	Yes	N/A	Ramp inside XWalk2?	N/A
	Road Slope (%)	N/A	N/A	Clear Space?	N/A
	Road X Slope (%)	N/A	N/A	Clear Space to XWalk (in)	N/A
N/A	Any Obstructions?	N/A	N/A	Storm Grate/Utility Hazard?	N/A
	Obstruction Type			Storm Grate/Utility Type	
		N/A			N/A
			Yes	Surface Condition? (G/P)	Good

Remove & Replace Entire Ramp.
