# Access Compliance Report

## Public Rights-of-Way

### (Curb Ramps)

| ADA ID: 792E8D6FF98E | Ramp Type: PerpDiag | Initial Pass/Fail: Pass | Overall Compliance: No |

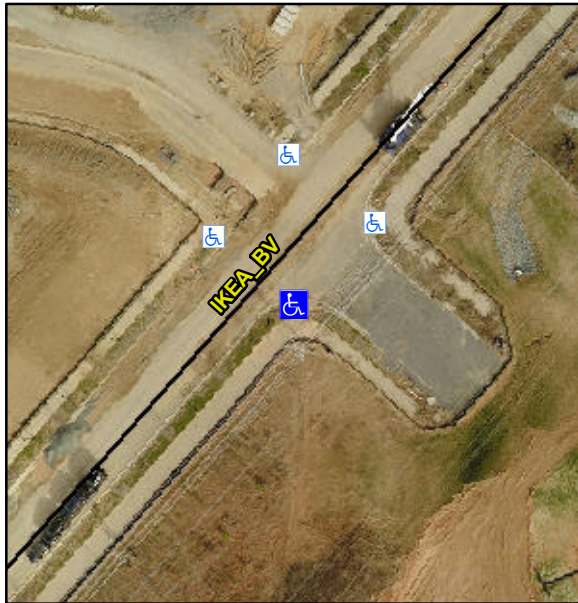
**R304.5.3, R304.2.2-Perp, R304.3.2-Para, R302.7.2**

| Compliance | Description | Data | Compliance | Description | Data |
|---|---|---|---|---|---|
| Yes | Ramp Width (in) | <b>59.0</b> | No | Ramp XSlope (%) | <b>3.6</b> |
| No | Landing Slope (%) | <b>2.4</b> | Yes | DWS Length (in) | <b>24.0</b> |
| No | Gutter Lip Ht (in) | <b>2.6</b> | Yes | Gutter X Slope (%) | <b>0.1</b> |

**Remove & Replace Curb Ramp With Two New Directional Ramps or Equivalent. Grind Gutter Lip.**
