Access Compliance Report Public Rights-of-Way (Curb Ramps)

Intersection ID: 12809 Main Street: N MCDOWELL ST Cross Street: E 7TH ST Location:

ADA ID: 7937B94A3B59 Ramp Type: PerpDiag Initial Pass/Fail: Fail **Overall Compliance: No** Severity Score: 46.25

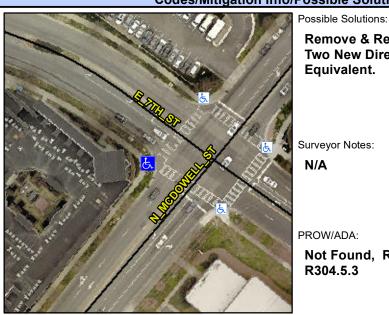
Not Found, R304.5.1, R304.2.2, R304.5.3

Comp	liance Description	Data	Comp	liance Description	Data
N/A	Ramp Length (in)	96.0	No	Ramp Slope (%)	8.8
No	Ramp Width (in)	38.0	No	Ramp XSlope (%)	8.3
N/A	Flare Type LT	N/A	N/A	Flare Type RT	N/A
N/A	Flare Slope LT (%)	N/A	N/A	Flare Slope RT (%)	N/A
N/A	Flare Traversable LT?	N/A	N/A	Flare Traversable RT?	N/A
N/A	Landing Length (in)	N/A	N/A	DWS Provided?	N/A
N/A	Landing Width (in)	N/A	N/A	DWS Contrast?	N/A
N/A	Landing Slope (%)	N/A	N/A	DWS Length (in)	N/A
N/A	Landing X Slope (%)	N/A	N/A	DWS Full Width?	N/A
N/A	Landing Curb? (Y/N)	N/A	N/A	DWS Offset (in)	N/A
N/A	Shared Landing?	N/A			
N/A	Gutter Ponding?	N/A	N/A	Gutter Slope (%)	N/A
N/A	Gutter Lip Ht (in)	N/A	N/A	Gutter X Slope (%)	N/A
N/A	Painted X Walk1?	Yes	N/A	Painted X Walk2?	Yes
	X Walk 1 Direction	To SE		X Walk 2 Direction	To NE
N/A	X Walk 1 Width (in)	111.0	N/A	X Walk 2 Width (in)	110.0
	X Walk 1 Slope (%)	2.0		X Walk 2 Slope (%)	3.5
	X Walk 1 X Slope (%)	2.9		X Walk 2 X Slope (%)	2.5

N/A	Ramp inside XWalk1?	Yes	N/A	Ramp inside XWalk2?	Yes
	Road Slope (%)	0.1	N/A	Clear Space?	N/A
	Road X Slope (%)	2.8	N/A	Clear Space to XWalk (in)	N/A
N/A	Any Obstructions?	N/A	N/A	Storm Grate/Utility Hazard?	N/A
	Obstruction Type		l	Storm Grate/Utility Type	
		N/A			N/A
			Yes	Surface Condition? (G/P)	Good

Remove & Replace Curb Ramp With **Two New Directional Ramps or** Equivalent.
