# Access Compliance Report

## Public Rights-of-Way

### (Curb Ramps)

Intersection ID: 12728	Main Street: E_10TH_ST	Cross Street: SEIGLE_AV	Location: SW
ADA ID: 793BF8D16693	Ramp Type: PerpDiag	Initial Pass/Fail: Fail	Overall Compliance: No
		Severity Score: 10

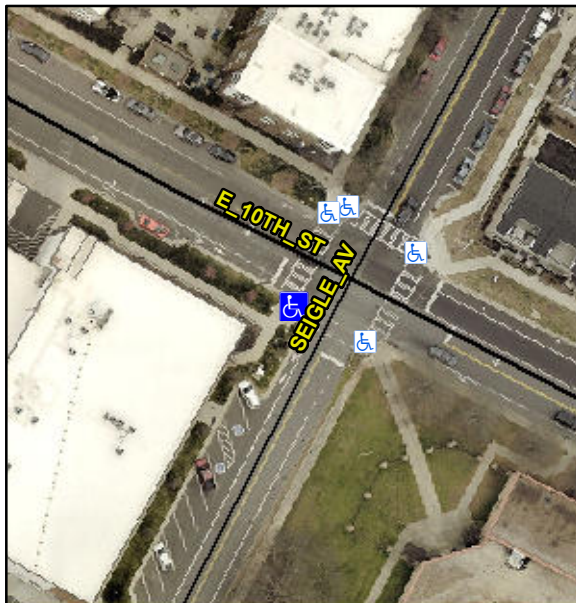
Compliance	Description	Data	Compliance	Description	Data
N/A	Ramp Length (in)	62.0	Yes	Ramp Slope (%)	6.3
No	Ramp Width (in)	47.5	No	Ramp XSlope (%)	3.4
N/A	Flare Type LT	N/A	N/A	Flare Type RT	N/A
N/A	Flare Slope LT (%)	N/A	N/A	Flare Slope RT (%)	N/A
N/A	Flare Traversable LT?	N/A	N/A	Flare Traversable RT?	N/A
N/A	Landing Length (in)	N/A	N/A	DWS Provided?	N/A
N/A	Landing Width (in)	N/A	N/A	DWS Contrast?	N/A
N/A	Landing Slope (%)	N/A	N/A	DWS Length (in)	N/A
N/A	Landing X Slope (%)	N/A	N/A	DWS Full Width?	N/A
N/A	Landing Curb? (Y/N)	N/A	N/A	DWS Offset (in)	N/A
N/A	Shared Landing?	N/A			
N/A	Gutter Ponding?	Yes	N/A	Gutter Slope (%)	N/A
N/A	Gutter Lip Ht (in)	N/A	N/A	Gutter X Slope (%)	N/A
N/A	Painted X Walk1?	Yes	N/A	Painted X Walk2?	Yes
	X Walk 1 Direction	To SE		X Walk 2 Direction	To NE
N/A	X Walk 1 Width (in)	89.0	N/A	X Walk 2 Width (in)	104.0
	X Walk 1 Slope (%)	6.2		X Walk 2 Slope (%)	2.0
	X Walk 1 X Slope (%)	2.2		X Walk 2 X Slope (%)	7.4

N/A	Ramp inside XWalk1?	Yes	N/A	Ramp inside XWalk2?	Yes
	Road Slope (%)	1.4	N/A	Clear Space?	N/A
	Road X Slope (%)	3.8	N/A	Clear Space to XWalk (in)	N/A
N/A	Any Obstructions?	N/A	N/A	Storm Grate/Utility Hazard?	N/A
	Obstruction Type			Storm Grate/Utility Type	
		N/A			N/A
			Yes	Surface Condition? (G/P)	Good

**Remove & Replace Curb Ramp With Two New Directional Ramps or Equivalent.**

**R304.5.1, R304.5.3**
