Access Compliance Report Public Rights-of-Way (Curb Ramps)

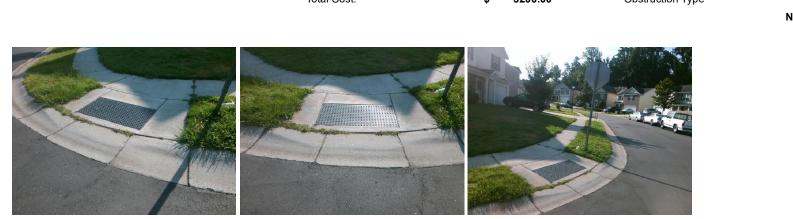
· · · · · · · · · · · · · · · · · · ·									
Intersection ID: 49506	Main Street: OSCEOLA_LN			Cross Street: WATERLOO_DR				Location:	Е
ADA ID: 793E4DF00DE6	Ramp Type: PerpDiag			nitial Pass/Fail: Fail Overall Compliance: No				o Severity Score:	22.5
Codes/Mitigation Info/Possible Solution				Field Measurements/Component Compliance					
		Possible Solutions:		Compliance Description		Data Compliance Description		Data	
		Remove & Replace Curb Ram	o With	N/A	Ramp Length (in)	49.0	No	Ramp Slope (%)	8.9
		Two New Directional Ramps or Equivalent.		No	Ramp Width (in)	39.0	No	Ramp XSlope (%)	3.5
				N/A	Flare Type LT	N/A	N/A	Flare Type RT	N/A
				N/A	Flare Slope LT (%)	N/A	N/A	Flare Slope RT (%)	N/A
				N/A	Flare Traversable LT?	N/A	N/A	Flare Traversable RT?	N/A
				N/A	Landing Length (in)	N/A	N/A	DWS Provided?	N/A
		Surveyor Notes:		N/A	Landing Width (in)	N/A	N/A	DWS Contrast?	N/A
		N/A		N/A	Landing Slope (%)	N/A	N/A	DWS Length (in)	N/A

N/A	Landing X Slope (%)	N/A	N/A	DWS Full Width?	N/A
O E				N/A	Landing Curb? (Y/N)	N/A	N/A	DWS Offset (in)	N/A
2.9/1/ 1000		u		N/A	Shared Landing?	N/A			
		PROW/ADA:		N/A	Gutter Ponding?	N/A	N/A	Gutter Slope (%)	N/A
	A 120 2001	Not Found, R304.5.1, R304.2.2,	2.	N/A	Gutter Lip Ht (in)	N/A	N/A	Gutter X Slope (%)	N/A
	A State State	R304.5.3	-,	N/A	Painted X Walk1?	No	N/A	Painted X Walk2?	No
					X Walk 1 Direction	To NW		X Walk 2 Direction	To SW
	P.J. AN A			N/A	X Walk 1 Width (in)	N/A	N/A	X Walk 2 Width (in)	N/A
Street 1 Name	OSCEOLA LN	-			X Walk 1 Slope (%)	3.1		X Walk 2 Slope (%)	6.4
Stop Condition-Street 2	None				X Walk 1 X Slope (%)	4.6		X Walk 2 X Slope (%)	1.8
Street 2 Name	WATERLOO DR			N/A	Ramp inside XWalk1?	N/A	N/A	Ramp inside XWalk2?	N/A
Stop Condition-Street 1	StopSign				Road Slope (%)	3.3	N/A	Clear Space?	N/A
					Road X Slope (%)	6.0	N/A	Clear Space to XWalk (in)	N/A
				N/A	Any Obstructions?	N/A	N/A	Storm Grate/Utility Hazard?	N/A

Total Cost: \$	3200.00		Obstruction Type			Storm Grate/Utility Type	
						N/A			N/A
							•
