Access Compliance Report

Public Rights-of-Way

(Curb Ramps)

| Intersection ID: 10020348 | | Main Street: BALLANTYNE COMMONS PY | | Cross Street: N/A | | Location: | | SE | |

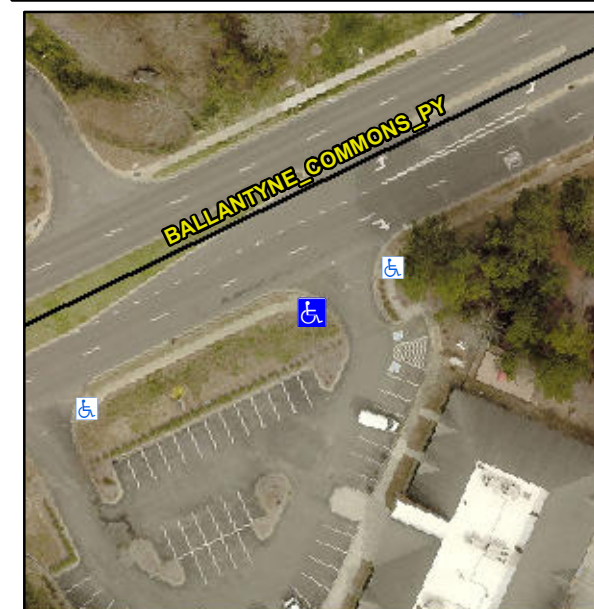
| ADA ID: 797BBD469E2B | | Ramp Type: Perp | | Initial Pass/Fail: Fail | | Overall Compliance: No | | Severity Score: 60 | |

Not Found, R304.5.1, R304.5.3

| Compliance | Description | Data | Compliance | Description | Data |
|---|---|---|---|---|---|
| No | Ramp Width (in) | 29.0 | No | Ramp XSlope (%) | 10.8 |

Remove & Replace Entire Ramp.

Total Cost: \$ 1850.00
