## **Access Compliance Report Public Rights-of-Way** (Curb Ramps)

Main Street: E KINGSTON AV Cross Street: PARK RD Location: Intersection ID: 14633 Ν

Ramp Type: Perp Initial Pass/Fail: Fail **Overall Compliance: No** ADA ID: 797FDADB27CD Severity Score: 26.25

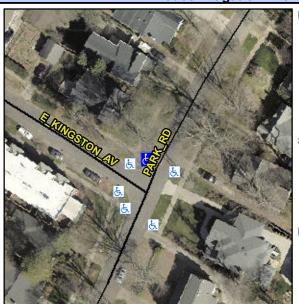
PARK RD Street 1 Name Stop Condition-Street 2 None Street 2 Name N/A Stop Condition-Street 1 N/A

Possible Solutions:	Compl	iance	Description
Remove & Replace Entire Ramp.	N/A	Ram	p Length (in)
•	Yes	Ram	p Width (in)
	N/A	Flare	Type LT
	N/A	Flare	e Slope LT (%)
	N/A	Flare	Traversable L1
	N/A	Land	ing Length (in)
Surveyor Notes:	N/A	Land	ing Width (in)
N/A	N/A	Land	ing Slope (%)
	N/A	Land	ing X Slope (%)
	N/A	Land	ing Curb? (Y/N)
	N/A	Shar	ed Landing?
PROW/ADA:	N/A	Gutte	er Ponding?
Not Found, R304.2.2	N/A	Gutte	er Lip Ht (in)
	N/A	Paint	ed X Walk1?
		X Wa	alk 1 Direction
	N/A	X Wa	alk 1 Width (in)
		X Wa	alk 1 Slope (%)
		X Wa	alk 1 X Slope (%
	N/A	Ram	p inside XWalk′
