# Access Compliance Report

## Public Rights-of-Way (Curb Ramps)

Intersection ID: 52293	Main Street: N_I-85_SERVICE_RD	Cross Street: N_TRYON_ST	Location: W
ADA ID: 798994C913C0	Ramp Type: Directional1	Initial Pass/Fail: Pass	Overall Compliance: No
		Severity Score: 7.5

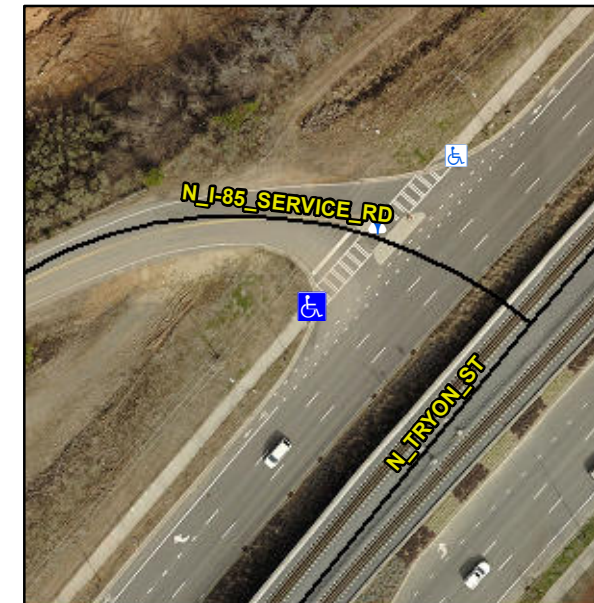
**R304.5.2, R302.7.2**

Compliance	Description	Data	Compliance	Description	Data
N/A	Ramp Length (in)	82.0	No	Grade Break?	No
Yes	Ramp Width (in)	94.0	N/A	Grade Break Slope (%)	N/A
Yes	Ramp Slope (%)	5.2	N/A	Grade Break XSlope (%)	N/A
Yes	Ramp XSlope (%)	1.5			
Yes	Flare Type LT	N/A	Yes	Flare Type RT	N/A
N/A	Flare Slope LT (%)	N/A	N/A	Flare Slope RT (%)	N/A
N/A	Flare Traversable LT?	No	N/A	Flare Traversable RT?	No
Yes	Landing Length (in)	65.0	Yes	DWS Provided?	Yes
Yes	Landing Width (in)	96.0	Yes	DWS Contrast?	Yes
Yes	Landing Slope (%)	0.6	Yes	DWS Length (in)	24.0
Yes	Landing X Slope (%)	0.8	Yes	DWS Full Width?	Yes
N/A	Landing Curb? (Y/N)	N/A	Yes	DWS Offset LT (in)	0.0
N/A	Shared Landing?	No	Yes	DWS Offset RT (in)	0.0
Yes	Gutter Ponding?	No	Yes	Gutter Slope (%)	4.5
No	Gutter Lip Ht (in)	0.5	Yes	Gutter X Slope (%)	0.8
N/A	Painted X Walk1?	Yes		Road Slope (%)	0.4
	X Walk 1 Direction	To NE		Road X Slope (%)	0.9
	X Walk 1 Width (in)	122.0		Clear Space?	Yes

X Walk 1 Slope (%)	0.4	N/A	Clear Space to XWalk (in)	N/A
	X Walk 1 X Slope (%)	0.9	Yes	Storm Grate/Utility Hazard?	No
Yes	Ramp inside XWalk1?	Yes		Storm Grate/Utility Type	
Yes	Any Obstructions?	No			N/A
	Obstruction Type		Yes	Surface Condition? (G/P)	Good
			N/A	Curb Slope (%)	N/A

**Remove & Replace Entire Ramp.  
Grind Gutter Lip.**
