Access Compliance Report

Public Rights-of-Way

(Curb Ramps)

Intersection ID: 12412	Main Street: BELMONT_AV	Cross Street: PEGRAM_ST	Location:	N
ADA ID: 799794E01261	Ramp Type: PerpDiag	Initial Pass/Fail: Fail	Overall Compliance: No	Severity Score: 10

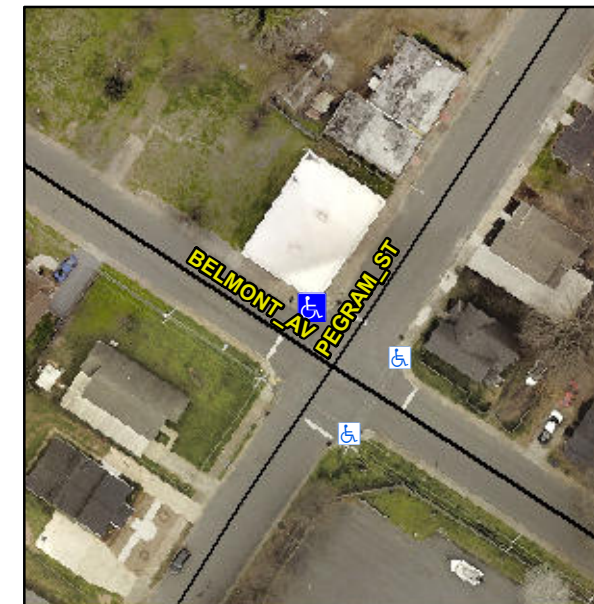
Not Found, R304.5.1, R304.5.3

Compliance	Description	Data	Compliance	Description	Data
N/A	Ramp Length (in)	24.0	Yes	Ramp Slope (%)	5.1
No	Ramp Width (in)	41.0	No	Ramp XSlope (%)	2.5
N/A	Flare Type LT	N/A	N/A	Flare Type RT	N/A
N/A	Flare Slope LT (%)	N/A	N/A	Flare Slope RT (%)	N/A
N/A	Flare Traversable LT?	N/A	N/A	Flare Traversable RT?	N/A
N/A	Landing Length (in)	N/A	N/A	DWS Provided?	N/A
N/A	Landing Width (in)	N/A	N/A	DWS Contrast?	N/A
N/A	Landing Slope (%)	N/A	N/A	DWS Length (in)	N/A
N/A	Landing X Slope (%)	N/A	N/A	DWS Full Width?	N/A
N/A	Landing Curb? (Y/N)	N/A	N/A	DWS Offset (in)	N/A
N/A	Shared Landing?	N/A			
N/A	Gutter Ponding?	N/A	N/A	Gutter Slope (%)	N/A
N/A	Gutter Lip Ht (in)	N/A	N/A	Gutter X Slope (%)	N/A
N/A	Painted X Walk1?	No	N/A	Painted X Walk2?	No
	X Walk 1 Direction	To SW		X Walk 2 Direction	To SE
N/A	X Walk 1 Width (in)	N/A	N/A	X Walk 2 Width (in)	N/A
	X Walk 1 Slope (%)	2.4		X Walk 2 Slope (%)	3.5
	X Walk 1 X Slope (%)	1.0		X Walk 2 X Slope (%)	1.6

N/A	Ramp inside XWalk1?	N/A	N/A	Ramp inside XWalk2?	N/A
	Road Slope (%)	0.1	N/A	Clear Space?	N/A
	Road X Slope (%)	2.3	N/A	Clear Space to XWalk (in)	N/A
N/A	Any Obstructions?	N/A	N/A	Storm Grate/Utility Hazard?	N/A
	Obstruction Type			Storm Grate/Utility Type	
		N/A			N/A
			Yes	Surface Condition? (G/P)	Good

Remove & Replace Curb Ramp With Two New Directional Ramps or Equivalent.
