Access Compliance Report

Public Rights-of-Way

(Curb Ramps)

Intersection ID: 5408	Main Street: CARVER_PL	Cross Street: ROCKWELL_BV	Location: W
ADA ID: 79AF855C484D	Ramp Type: Para	Initial Pass/Fail: Fail	Overall Compliance: No
		Severity Score: 35

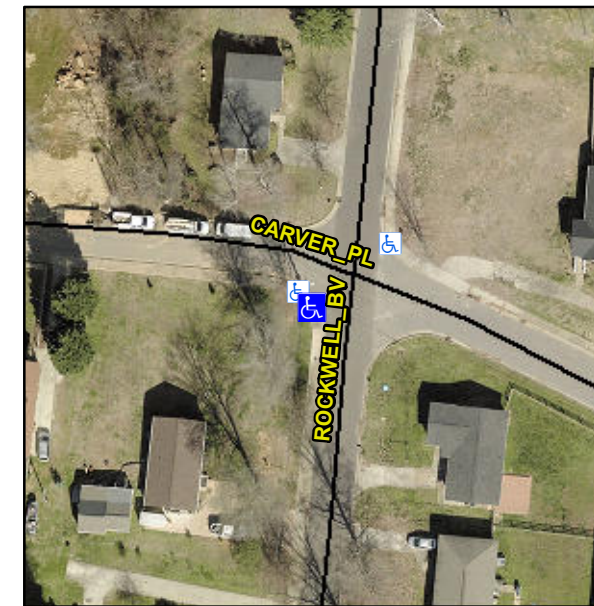
POWER POLE OBS

R304.5.1, R304.3.2, R304.5.3

Compliance	Description	Data	Compliance	Description	Data
N/A	Ramp Length LT (in)	36.0	N/A	Ramp Length RT (in)	41.0
No	Ramp Width LT (in)	38.0	No	Ramp Width RT (in)	43.0
No	Ramp Slope LT (%)	16.4	Yes	Ramp Slope RT (%)	5.8
Yes	Ramp XSlope LT (%)	1.8	No	Ramp XSlope RT (%)	2.1
N/A	Landing Length (in)	N/A	N/A	DWS Provided?	N/A
N/A	Landing Width (in)	N/A	N/A	DWS Contrast?	N/A
N/A	Landing Slope (%)	N/A	N/A	DWS Length (in)	N/A
N/A	Landing X Slope (%)	N/A	N/A	DWS Full Width?	N/A
N/A	Landing Curb? (Y/N)	N/A	N/A	DWS Offset (in)	N/A
N/A	Shared Landing?	N/A			
N/A	Gutter Ponding?	N/A	N/A	Gutter Slope (%)	N/A
N/A	Gutter Lip Ht (in)	N/A	N/A	Gutter X Slope (%)	N/A
N/A	Painted X Walk1?	No	N/A	Painted X Walk2?	N/A
	X Walk 1 Direction	To E		X Walk 2 Direction	N/A
N/A	X Walk 1 Width (in)	N/A	N/A	X Walk 2 Width (in)	N/A
	X Walk 1 Slope (%)	2.9		X Walk 2 Slope (%)	N/A
	X Walk 1 X Slope (%)	0.4		X Walk 2 X Slope (%)	N/A
N/A	Ramp inside XWalk1?	N/A	N/A	Ramp inside XWalk2?	N/A

Road Slope (%)	N/A	N/A	Clear Space?	N/A
	Road X Slope (%)	N/A	N/A	Clear Space to XWalk (in)	N/A
N/A	Any Obstructions?	N/A	N/A	Storm Grate/Utility Hazard?	N/A
	Obstruction Type			Storm Grate/Utility Type	
		N/A			N/A
			Yes	Surface Condition? (G/P)	Good
			N/A	Curb Slope (%)	N/A

Remove & Replace Entire Ramp.
