# Access Compliance Report

## Public Rights-of-Way

### (Curb Ramps)

Intersection ID: 29994	Main Street: BRIGHTHAVEN_LN	Cross Street: WINDING_RIVER_DR	Location: S
ADA ID: 79BD6B6B6747	Ramp Type: Perp	Initial Pass/Fail: Fail	Overall Compliance: No
			Severity Score: 21.25

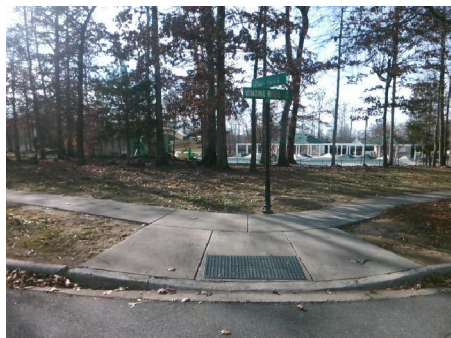
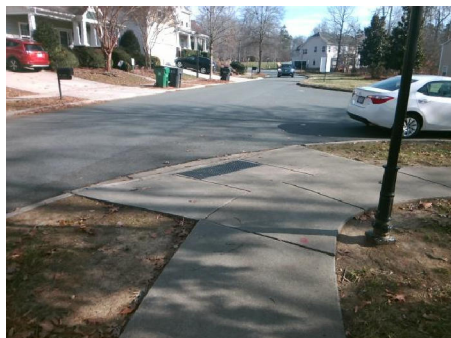
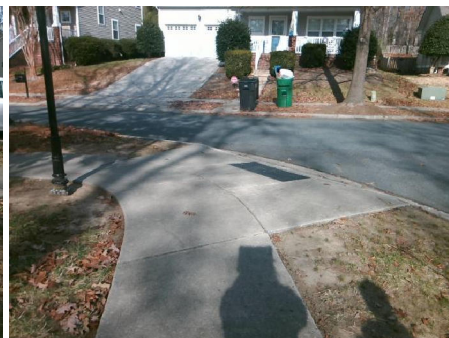
Possible Solutions:		<b>Compliance</b>	<b>Description</b>	<b>Data</b>
	<b>Remove &amp; Replace Entire Ramp.</b>		<b>Compliance</b>	<b>Description</b>	<b>Data</b>
<p>Surveyor Notes:</p> <p><b>N/A</b></p> <p>PROW/ADA:</p> <p><b>Not Found, R304.5.1, R304.2.2</b></p>			<b>No</b>	Ramp Length (in)	<b>64.0</b>
			<b>No</b>	Ramp Width (in)	<b>44.0</b>
			<b>N/A</b>	Flare Type LT	<b>N/A</b>
			<b>N/A</b>	Flare Slope LT (%)	<b>N/A</b>
			<b>N/A</b>	Flare Traversable LT?	<b>N/A</b>
			<b>N/A</b>	Landing Length (in)	<b>N/A</b>
			<b>N/A</b>	Landing Width (in)	<b>N/A</b>
			<b>N/A</b>	Landing Slope (%)	<b>N/A</b>
			<b>N/A</b>	Landing X Slope (%)	<b>N/A</b>
			<b>N/A</b>	Landing Curb? (Y/N)	<b>N/A</b>
			<b>N/A</b>	Shared Landing?	<b>N/A</b>
			<b>N/A</b>	Gutter Ponding?	<b>N/A</b>
			<b>N/A</b>	Gutter Lip Ht (in)	<b>N/A</b>
			<b>N/A</b>	Painted X Walk1?	<b>No</b>

X Walk 1 Direction	<b>To N</b>
			<b>N/A</b>	X Walk 1 Width (in)	<b>N/A</b>
				X Walk 1 Slope (%)	<b>6.0</b>
				X Walk 1 X Slope (%)	<b>2.8</b>
			<b>N/A</b>	Ramp inside XWalk1?	<b>N/A</b>
				Road Slope (%)	<b>N/A</b>
				Road X Slope (%)	<b>N/A</b>
			<b>N/A</b>	Any Obstructions?	<b>N/A</b>
				Obstruction Type	
			<b>N/A</b>		<b>N/A</b>
			<b>Yes</b>	Surface Condition? (G/P)	<b>Good</b>

Total Cost: \$ 1850.00
