# Access Compliance Report

## Public Rights-of-Way

### (Curb Ramps)

Intersection ID: 44822	Main Street: GOLDEN_RIDGE_LN	Cross Street: HIRAM_ST	Location: SE
ADA ID: 79C1F7C11E25	Ramp Type: PerpDiag	Initial Pass/Fail: Fail	Overall Compliance: No
Codes/Mitigation Info/Possible Solution			Severity Score: 10
			Field Measurements/Component Compliance

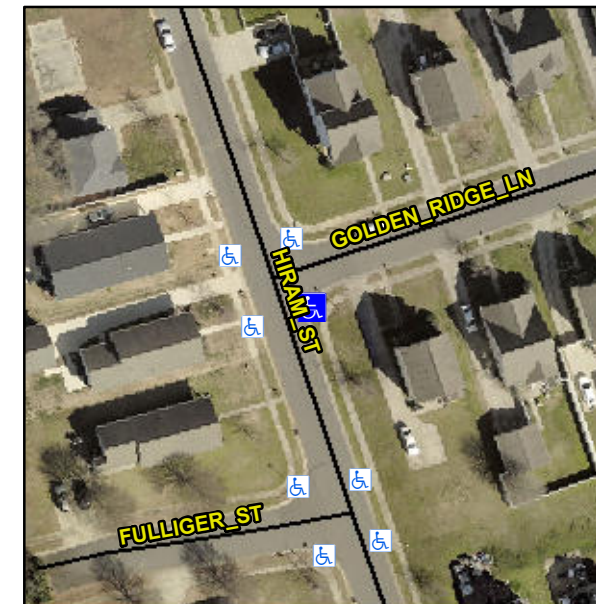
Compliance	Description	Data	Compliance	Description	Data
N/A	Ramp Length (in)	49.0	Yes	Ramp Slope (%)	5.4
No	Ramp Width (in)	42.5	No	Ramp XSlope (%)	4.1
N/A	Flare Type LT	N/A	N/A	Flare Type RT	N/A
N/A	Flare Slope LT (%)	N/A	N/A	Flare Slope RT (%)	N/A
N/A	Flare Traversable LT?	N/A	N/A	Flare Traversable RT?	N/A
N/A	Landing Length (in)	N/A	N/A	DWS Provided?	N/A
N/A	Landing Width (in)	N/A	N/A	DWS Contrast?	N/A
N/A	Landing Slope (%)	N/A	N/A	DWS Length (in)	N/A
N/A	Landing X Slope (%)	N/A	N/A	DWS Full Width?	N/A
N/A	Landing Curb? (Y/N)	N/A	N/A	DWS Offset (in)	N/A
N/A	Shared Landing?	N/A			
N/A	Gutter Ponding?	N/A	N/A	Gutter Slope (%)	N/A
N/A	Gutter Lip Ht (in)	N/A	N/A	Gutter X Slope (%)	N/A
N/A	Painted X Walk1?	No	N/A	Painted X Walk2?	No
	X Walk 1 Direction	To N		X Walk 2 Direction	To W
N/A	X Walk 1 Width (in)	N/A	N/A	X Walk 2 Width (in)	N/A
	X Walk 1 Slope (%)	8.7		X Walk 2 Slope (%)	5.0
	X Walk 1 X Slope (%)	6.4		X Walk 2 X Slope (%)	4.1

N/A	Ramp inside XWalk1?	N/A	N/A	Ramp inside XWalk2?	N/A
	Road Slope (%)	1.5	N/A	Clear Space?	N/A
	Road X Slope (%)	10.0	N/A	Clear Space to XWalk (in)	N/A
N/A	Any Obstructions?	N/A	N/A	Storm Grate/Utility Hazard?	N/A
	Obstruction Type			Storm Grate/Utility Type	
		N/A			N/A
			Yes	Surface Condition? (G/P)	Good

Possible Solutions:

**Remove & Replace Curb Ramp With Two New Directional Ramps or Equivalent.**

**R304.5.1, R304.5.3**
