Access Compliance Report

Public Rights-of-Way

(Curb Ramps)

Intersection ID: N/A	Main Street: SUMMERFIELD RIDGE LN	Cross Street: CALABASSAS LN	Location: NW
ADA ID: 79DC94CD9C24	Ramp Type: PerpDiag	Initial Pass/Fail: Fail	Overall Compliance: No
Codes/Mitigation Info/Possible Solution		Field Measurements/Component Compliance

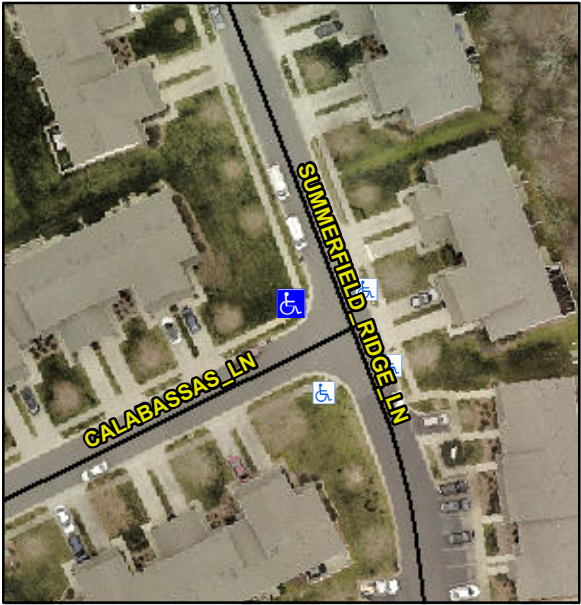
Possible Solutions:	Compliance	Description	Data	Compliance	Description	Data
	Remove & Replace Curb Ramp With Two New Directional Ramps or Equivalent.	N/A	Ramp Length (in)	47.0	No	Ramp Slope (%)	11.5
<p>Surveyor Notes:</p> <p>N/A</p> <p>PROW/ADA:</p> <p>R304.5.1, R304.2.2, R304.5.3</p>		No	Ramp Width (in)	41.0	No	Ramp XSlope (%)	5.2
		N/A	Flare Type LT	N/A	N/A	Flare Type RT	N/A
		N/A	Flare Slope LT (%)	N/A	N/A	Flare Slope RT (%)	N/A
		N/A	Flare Traversable LT?	No	N/A	Flare Traversable RT?	No
		N/A	Landing Length (in)	N/A	N/A	DWS Provided?	N/A
		N/A	Landing Width (in)	N/A	N/A	DWS Contrast?	N/A
		N/A	Landing Slope (%)	N/A	N/A	DWS Length (in)	N/A
		N/A	Landing X Slope (%)	N/A	N/A	DWS Full Width?	N/A
		N/A	Landing Curb? (Y/N)	N/A	N/A	DWS Offset (in)	N/A
		N/A	Shared Landing?	N/A			
		N/A	Gutter Ponding?	N/A	N/A	Gutter Slope (%)	N/A
		N/A	Gutter Lip Ht (in)	N/A	N/A	Gutter X Slope (%)	N/A
		N/A	Painted X Walk1?	No	N/A	Painted X Walk2?	No

X Walk 1 Direction	To S		X Walk 2 Direction	To E
		N/A	X Walk 1 Width (in)	N/A	N/A	X Walk 2 Width (in)	N/A
			X Walk 1 Slope (%)	3.9		X Walk 2 Slope (%)	0.5
			X Walk 1 X Slope (%)	1.0		X Walk 2 X Slope (%)	4.9
		N/A	Ramp inside XWalk1?	N/A	N/A	Ramp inside XWalk2?	N/A
			Road Slope (%)	3.6	N/A	Clear Space?	N/A
			Road X Slope (%)	4.0	N/A	Clear Space to XWalk (in)	N/A
		N/A	Any Obstructions?	N/A	N/A	Storm Grate/Utility Hazard?	N/A
			Obstruction Type			Storm Grate/Utility Type	
					N/A		N/A
					Yes	Surface Condition? (G/P)	Good
Total Cost:		\$	3200.00
