# Access Compliance Report

## Public Rights-of-Way

### (Curb Ramps)

Intersection ID: 3117	Main Street: BASKERVILLE_AV	Cross Street: BUCKMINSTER_CT	Location:	E
ADA ID: 79DCB5FDE81C	Ramp Type: Perp	Initial Pass/Fail: Fail	Overall Compliance: No	Severity Score: 50
Codes/Mitigation Info/Possible Solution		Field Measurements/Component Compliance

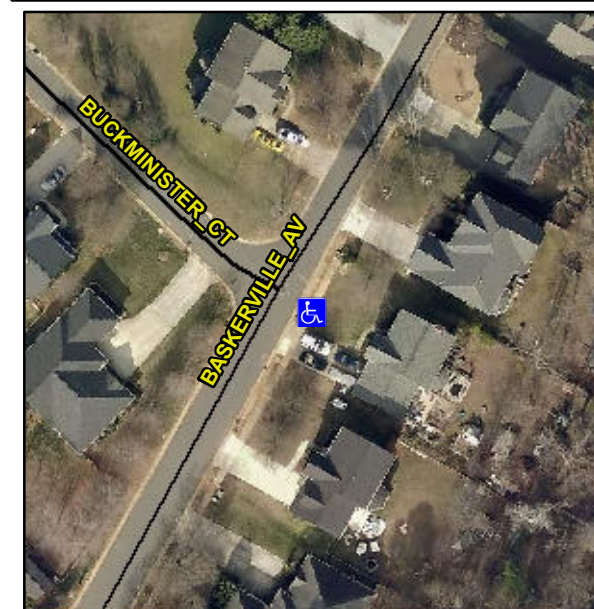
**Not Found, R304.2.2, R304.5.3**

Compliance	Description	Data	Compliance	Description	Data
N/A	Ramp Length (in)	48.0	No	Ramp Slope (%)	12.2
Yes	Ramp Width (in)	48.0	No	Ramp XSlope (%)	12.7
N/A	Flare Type LT	N/A	N/A	Flare Type RT	N/A
N/A	Flare Slope LT (%)	N/A	N/A	Flare Slope RT (%)	N/A
N/A	Flare Traversable LT?	N/A	N/A	Flare Traversable RT?	N/A
N/A	Landing Length (in)	N/A	N/A	DWS Provided?	N/A
N/A	Landing Width (in)	N/A	N/A	DWS Contrast?	N/A
N/A	Landing Slope (%)	N/A	N/A	DWS Length (in)	N/A
N/A	Landing X Slope (%)	N/A	N/A	DWS Full Width?	N/A
N/A	Landing Curb? (Y/N)	N/A	N/A	DWS Offset (in)	N/A
N/A	Shared Landing?	N/A			
N/A	Gutter Ponding?	N/A	N/A	Gutter Slope (%)	N/A
N/A	Gutter Lip Ht (in)	N/A	N/A	Gutter X Slope (%)	N/A
N/A	Painted X Walk1?	No	N/A	Painted X Walk2?	N/A
	X Walk 1 Direction	To NW		X Walk 2 Direction	N/A
N/A	X Walk 1 Width (in)	N/A	N/A	X Walk 2 Width (in)	N/A
	X Walk 1 Slope (%)	4.4		X Walk 2 Slope (%)	N/A
	X Walk 1 X Slope (%)	9.8		X Walk 2 X Slope (%)	N/A

N/A	Ramp inside XWalk1?	N/A	N/A	Ramp inside XWalk2?	N/A
	Road Slope (%)	N/A	N/A	Clear Space?	N/A
	Road X Slope (%)	N/A	N/A	Clear Space to XWalk (in)	N/A
N/A	Any Obstructions?	N/A	N/A	Storm Grate/Utility Hazard?	N/A
	Obstruction Type			Storm Grate/Utility Type	
		N/A			N/A
			Yes	Surface Condition? (G/P)	Good

Possible Solutions:

**Remove & Replace Entire Ramp.**

Total Cost: \$ 1850.00
