# Access Compliance Report

## Public Rights-of-Way

### (Curb Ramps)

Intersection ID: 44490	Main Street: CHALKSTONE_RD	Cross Street: DARWICK_ST	Location: SE
ADA ID: 79DFEFB1EF03	Ramp Type: Perp	Initial Pass/Fail: Fail	Overall Compliance: No
Severity Score: 21.25			
Codes/Mitigation Info/Possible Solution		Field Measurements/Component Compliance

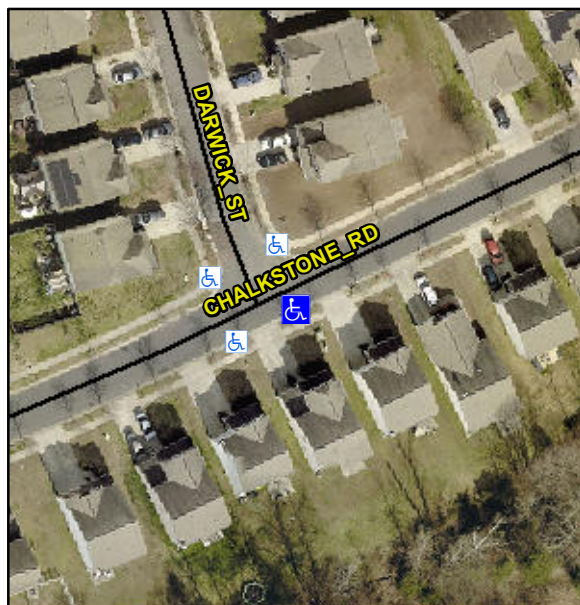
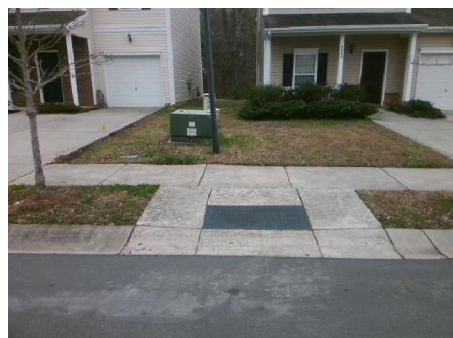
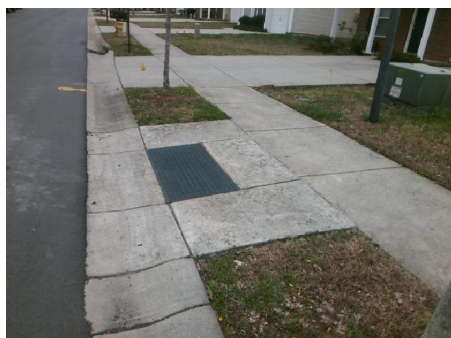
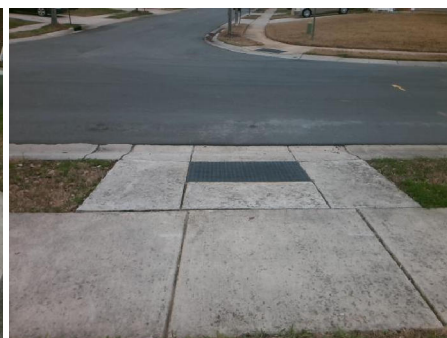
**Not Found, R304.5.1, R304.2.2**

Compliance	Description	Data	Compliance	Description	Data
N/A	Ramp Length (in)	49.0	No	Ramp Slope (%)	9.4
No	Ramp Width (in)	47.0	Yes	Ramp XSlope (%)	1.2
N/A	Flare Type LT	N/A	N/A	Flare Type RT	N/A
N/A	Flare Slope LT (%)	N/A	N/A	Flare Slope RT (%)	N/A
N/A	Flare Traversable LT?	N/A	N/A	Flare Traversable RT?	N/A
N/A	Landing Length (in)	N/A	N/A	DWS Provided?	N/A
N/A	Landing Width (in)	N/A	N/A	DWS Contrast?	N/A
N/A	Landing Slope (%)	N/A	N/A	DWS Length (in)	N/A
N/A	Landing X Slope (%)	N/A	N/A	DWS Full Width?	N/A
N/A	Landing Curb? (Y/N)	N/A	N/A	DWS Offset (in)	N/A
N/A	Shared Landing?	N/A			
N/A	Gutter Ponding?	N/A	N/A	Gutter Slope (%)	N/A
N/A	Gutter Lip Ht (in)	N/A	N/A	Gutter X Slope (%)	N/A
N/A	Painted X Walk1?	No	N/A	Painted X Walk2?	N/A
	X Walk 1 Direction	To N		X Walk 2 Direction	N/A
N/A	X Walk 1 Width (in)	N/A	N/A	X Walk 2 Width (in)	N/A
	X Walk 1 Slope (%)	3.2		X Walk 2 Slope (%)	N/A
	X Walk 1 X Slope (%)	1.0		X Walk 2 X Slope (%)	N/A

N/A	Ramp inside XWalk1?	N/A	N/A	Ramp inside XWalk2?	N/A
	Road Slope (%)	N/A	N/A	Clear Space?	N/A
	Road X Slope (%)	N/A	N/A	Clear Space to XWalk (in)	N/A
N/A	Any Obstructions?	N/A	N/A	Storm Grate/Utility Hazard?	N/A
	Obstruction Type			Storm Grate/Utility Type	
		N/A			N/A
			Yes	Surface Condition? (G/P)	Good

**Remove & Replace Entire Ramp.**
