Access Compliance Report Public Rights-of-Way (Curb Ramps)

Intersection ID: 31630 Main Street: CALTON_LN Cross Street: CHARLES_PATRICK_CT Location: N

ADA ID: 79FF8DB39904 Ramp Type: Perp Initial Pass/Fail: Fail Overall Compliance: No Severity Score: 8.75

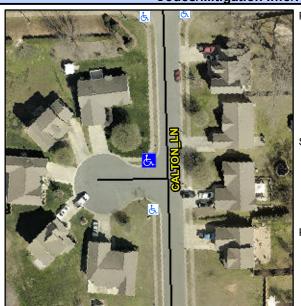
| Field Measurements/Component Compnance | | | | | | |
|--|---|---|---|---|---|---|
| | N/A | Ramp Length (in) | 49.0 | Yes | Ramp Slope (%) | 6.5 |
| | No | Ramp Width (in) | 40.0 | Yes | Ramp XSlope (%) | 0.5 |

Total Cost: \$ 1850.00
