# Access Compliance Report

## Public Rights-of-Way

### (Curb Ramps)

Intersection ID: 46822	Main Street: RED_BIRCH_DR	Cross Street: SCOTCH_PINE_CR	Location: NW
ADA ID: 7A0160824265	Ramp Type: PerpDiag	Initial Pass/Fail: Fail	Overall Compliance: No
		Severity Score: 8.75

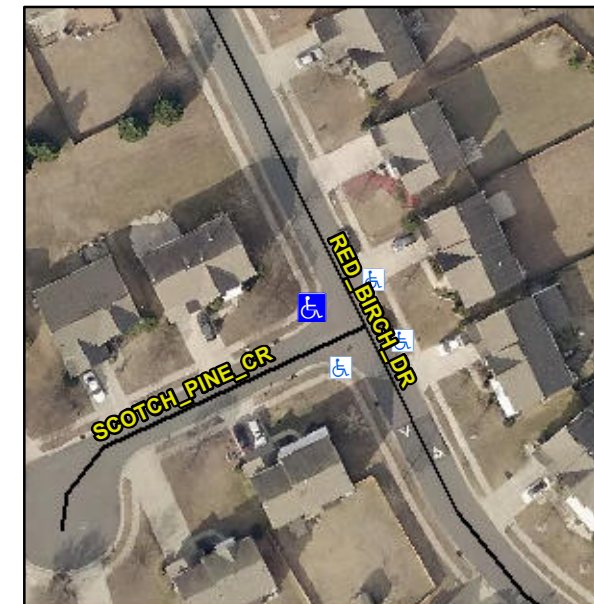
**Not Found, R304.5.1**

Compliance	Description	Data	Compliance	Description	Data
N/A	Ramp Length (in)	49.0	Yes	Ramp Slope (%)	5.8
No	Ramp Width (in)	38.0	Yes	Ramp XSlope (%)	0.7
N/A	Flare Type LT	N/A	N/A	Flare Type RT	N/A
N/A	Flare Slope LT (%)	N/A	N/A	Flare Slope RT (%)	N/A
N/A	Flare Traversable LT?	N/A	N/A	Flare Traversable RT?	N/A
N/A	Landing Length (in)	N/A	N/A	DWS Provided?	N/A
N/A	Landing Width (in)	N/A	N/A	DWS Contrast?	N/A
N/A	Landing Slope (%)	N/A	N/A	DWS Length (in)	N/A
N/A	Landing X Slope (%)	N/A	N/A	DWS Full Width?	N/A
N/A	Landing Curb? (Y/N)	N/A	N/A	DWS Offset (in)	N/A
N/A	Shared Landing?	N/A			
N/A	Gutter Ponding?	N/A	N/A	Gutter Slope (%)	N/A
N/A	Gutter Lip Ht (in)	N/A	N/A	Gutter X Slope (%)	N/A
N/A	Painted X Walk1?	No	N/A	Painted X Walk2?	No
	X Walk 1 Direction	To S		X Walk 2 Direction	To E
N/A	X Walk 1 Width (in)	N/A	N/A	X Walk 2 Width (in)	N/A
	X Walk 1 Slope (%)	1.3		X Walk 2 Slope (%)	0.0
	X Walk 1 X Slope (%)	1.1		X Walk 2 X Slope (%)	3.7

N/A	Ramp inside XWalk1?	N/A	N/A	Ramp inside XWalk2?	N/A
	Road Slope (%)	1.4	N/A	Clear Space?	N/A
	Road X Slope (%)	1.8	N/A	Clear Space to XWalk (in)	N/A
N/A	Any Obstructions?	N/A	N/A	Storm Grate/Utility Hazard?	N/A
	Obstruction Type			Storm Grate/Utility Type	
		N/A			N/A
			Yes	Surface Condition? (G/P)	Good

**Remove & Replace Curb Ramp With Two New Directional Ramps or Equivalent.**
