Access Compliance Report Public Rights-of-Way (Curb Ramps)

Intersection ID: 14441 Main Street: E_KINGSTON_AV Cross Street: SPRINGDALE_AV Location: N

ADA ID: 7A0CCB3ABEA6 Ramp Type: Directional1 Initial Pass/Fail: Fail Overall Compliance: No Severity Score: 26.25

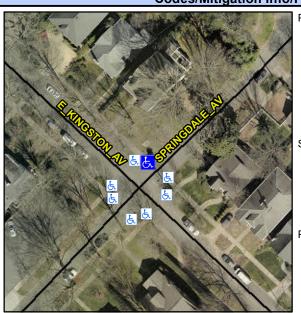
R304.2.2, R304.5.3

Field Measurements/Component Compliance					
Compliance Description		Data	Compliance Description		Data
N/A	Ramp Length (in)	90.0	N/A	Grade Break?	N/A
Yes	Ramp Width (in)	48.0	N/A	Grade Break Slope (%)	0.0
No	Ramp Slope (%)	13.0	N/A	Grade Break XSlope (%)	0.0
No	Ramp XSlope (%)	2.7			
N/A	Flare Type LT	N/A	N/A	Flare Type RT	N/A
N/A	Flare Slope LT (%)	N/A	N/A	Flare Slope RT (%)	0.0
N/A	Flare Traversable LT?	N/A	N/A	Flare Traversable RT?	N/A
N/A	Landing Length (in)	0.0	N/A	DWS Provided?	N/A
N/A	Landing Width (in)	0.0	N/A	DWS Contrast?	N/A
N/A	Landing Slope (%)	0.0	N/A	DWS Length (in)	N/A
N/A	Landing X Slope (%)	0.0	N/A	DWS Full Width?	N/A
N/A	Landing Curb? (Y/N)	N/A	N/A	DWS Offset LT (in)	N/A
N/A	Shared Landing?	N/A	N/A	DWS Offset RT (in)	N/A
N/A	Gutter Ponding?	0.0	N/A	Gutter Slope (%)	N/A
N/A	Gutter Lip Ht (in)	0.0	N/A	Gutter X Slope (%)	N/A
N/A	Painted X Walk1?	No		Road Slope (%)	1.5
	X Walk 1 Direction	To SE		Road X Slope (%)	3.9

X Walk 1 Width (in)	N/A		Clear Space?	N/A
	X Walk 1 Slope (%)	1.5	N/A	Clear Space to XWalk (in)	N/A
	X Walk 1 X Slope (%)	3.9	N/A	Storm Grate/Utility Hazard?	N/A
N/A	Ramp inside XWalk1?	N/A		Storm Grate/Utility Type	
N/A	Any Obstructions?	N/A			N/A
	Obstruction Type		Yes	Surface Condition? (G/P)	Good
		N/A	N/A	Curb Slope (%)	1.5

Possible Solutions:

Remove & Replace Entire Ramp.

Total Cost: \$ 1600.00
