Access Compliance Report

Public Rights-of-Way

(Curb Ramps)

Intersection ID: 25678	Main Street: CARMEL_EXECUTIVE_PARK	Cross Street: LITTLE_AV	Location: SW
ADA ID: 7A25D93A202A	Ramp Type: Perp	Initial Pass/Fail: Fail	Overall Compliance: No
Severity Score: 21.25			
Codes/Mitigation Info/Possible Solution		Field Measurements/Component Compliance

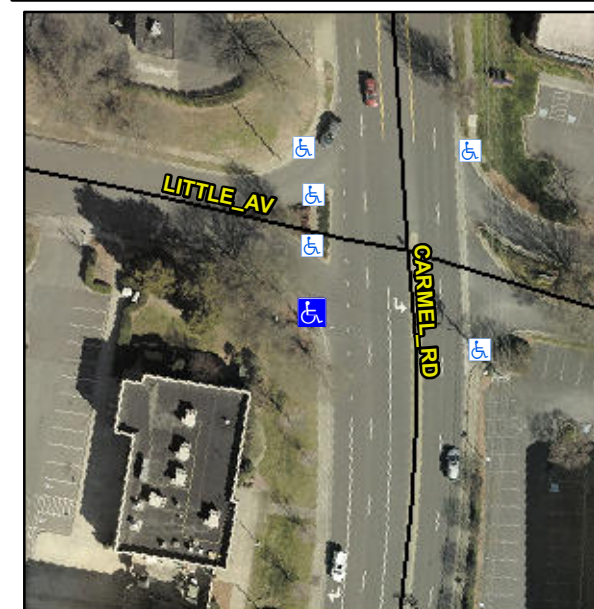
Not Found, R304.5.1, R304.2.2

Compliance	Description	Data	Compliance	Description	Data
N/A	Ramp Length (in)	60.0	No	Ramp Slope (%)	8.8
No	Ramp Width (in)	45.0	Yes	Ramp XSlope (%)	0.3
N/A	Flare Type LT	N/A	N/A	Flare Type RT	N/A
N/A	Flare Slope LT (%)	N/A	N/A	Flare Slope RT (%)	N/A
N/A	Flare Traversable LT?	N/A	N/A	Flare Traversable RT?	N/A
N/A	Landing Length (in)	N/A	N/A	DWS Provided?	N/A
N/A	Landing Width (in)	N/A	N/A	DWS Contrast?	N/A
N/A	Landing Slope (%)	N/A	N/A	DWS Length (in)	N/A
N/A	Landing X Slope (%)	N/A	N/A	DWS Full Width?	N/A
N/A	Landing Curb? (Y/N)	N/A	N/A	DWS Offset (in)	N/A
N/A	Shared Landing?	N/A			
N/A	Gutter Ponding?	N/A	N/A	Gutter Slope (%)	N/A
N/A	Gutter Lip Ht (in)	N/A	N/A	Gutter X Slope (%)	N/A
N/A	Painted X Walk1?	No	N/A	Painted X Walk2?	N/A
	X Walk 1 Direction	To N		X Walk 2 Direction	N/A
N/A	X Walk 1 Width (in)	N/A	N/A	X Walk 2 Width (in)	N/A
	X Walk 1 Slope (%)	0.8		X Walk 2 Slope (%)	N/A
	X Walk 1 X Slope (%)	1.9		X Walk 2 X Slope (%)	N/A

N/A	Ramp inside XWalk1?	N/A	N/A	Ramp inside XWalk2?	N/A
	Road Slope (%)	N/A	N/A	Clear Space?	N/A
	Road X Slope (%)	N/A	N/A	Clear Space to XWalk (in)	N/A
N/A	Any Obstructions?	N/A	N/A	Storm Grate/Utility Hazard?	N/A
	Obstruction Type			Storm Grate/Utility Type	
		N/A			N/A
		Yes		Surface Condition? (G/P)	Good

Possible Solutions:

Remove & Replace Entire Ramp.
