Access Compliance Report

Public Rights-of-Way

(Curb Ramps)

Intersection ID: 2625	Main Street: KILMARTIN_LN	Cross Street: TULLAMORE_LN	Location:	S
ADA ID: 7A2BFC0E1009	Ramp Type: BlendTrans1	Initial Pass/Fail: Fail	Overall Compliance: No	Severity Score: 10

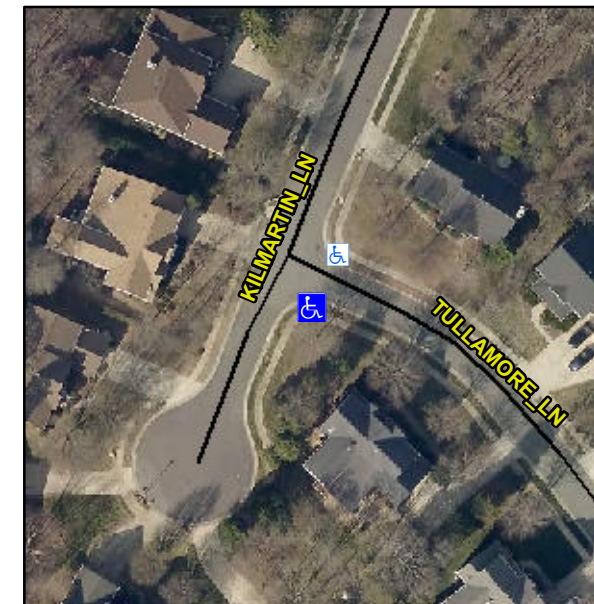
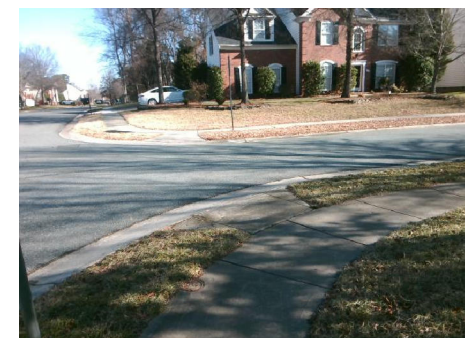
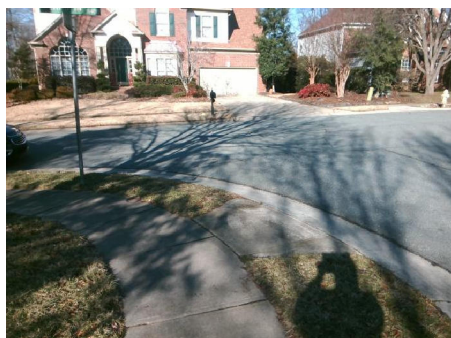
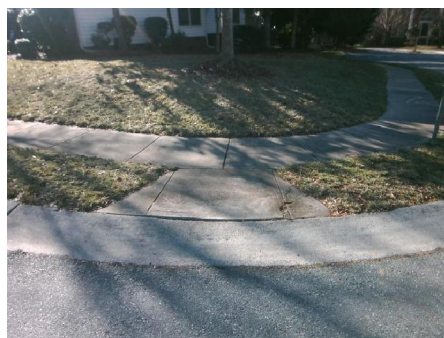
Not Found, R304.5.1, R304.5.3

Compliance	Description	Data	Compliance	Description	Data
N/A	Ramp Length (in)	46.0	Yes	BlendTrans Slope (%)	2.8
No	Ramp Width (in)	47.0	No	BlendTrans XSlope (%)	2.6
N/A	Flare Type LT	N/A	N/A	Flare Type RT	N/A
N/A	Flare Slope LT (%)	N/A	N/A	Flare Slope RT (%)	N/A
N/A	Flare Traversable LT?	N/A	N/A	Flare Traversable RT?	N/A
N/A	Landing Length (in)	N/A	N/A	DWS Provided?	N/A
N/A	Landing Width (in)	N/A	N/A	DWS Contrast?	N/A
N/A	Landing Slope (%)	N/A	N/A	DWS Length (in)	N/A
N/A	Landing X Slope (%)	N/A	N/A	DWS Full Width?	N/A
N/A	Landing Curb? (Y/N)	N/A	N/A	DWS Offset (in)	N/A
N/A	Shared Landing?	N/A			
N/A	Gutter Ponding?	N/A	N/A	Gutter Slope (%)	N/A
N/A	Gutter Lip Ht (in)	N/A	N/A	Gutter X Slope (%)	N/A
N/A	Painted X Walk1?	No	N/A	Painted X Walk2?	N/A
	X Walk 1 Direction	To NE		X Walk 2 Direction	N/A
	X Walk 1 Width (in)	N/A		X Walk 2 Width (in)	N/A
	X Walk 1 Slope (%)	1.1		X Walk 2 Slope (%)	N/A
	X Walk 1 X Slope (%)	0.9		X Walk 2 X Slope (%)	N/A

N/A	Ramp inside XWalk1?	N/A	N/A	Ramp inside XWalk2?	N/A
	Road Slope (%)	0.9		Clear Space?	N/A
	Road X Slope (%)	1.1	N/A	Clear Space to XWalk (in)	N/A
N/A	Any Obstructions?	N/A	N/A	Storm Grate/Utility Hazard?	N/A
	Obstruction Type			Storm Grate/Utility Type	
		N/A			N/A
			Yes	Surface Condition? (G/P)	Good
			No	Curb Slope (%)	16.7

Remove & Replace Curb Ramp With Two New Directional Ramps or Equivalent.
