Access Compliance Report

Public Rights-of-Way

(Curb Ramps)

Intersection ID: 4219	Main Street: DAVIS_LAKE_PY	Cross Street: UNIVERSITY_STATION_CR	Location: NW
ADA ID: 7A45AE7AA171	Ramp Type: Perp	Initial Pass/Fail: Fail	Overall Compliance: No
		Severity Score: 37.5

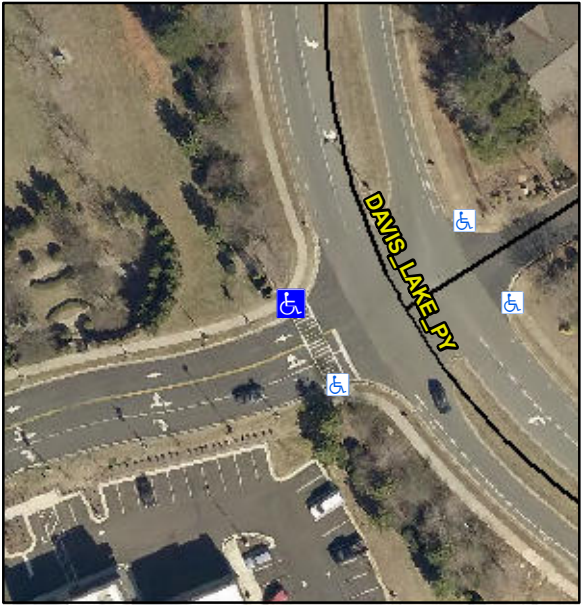
Possible Solutions:		Compliance	Description	Data
	Remove & Replace Entire Ramp.		No	Ramp Length (in)	46.5
			Yes	Ramp Width (in)	48.0
			N/A	Flare Type LT	N/A
			N/A	Flare Slope LT (%)	N/A
			N/A	Flare Traversable LT?	N/A
			N/A	Landing Length (in)	N/A
			N/A	Landing Width (in)	N/A
			N/A	Landing Slope (%)	N/A
			N/A	Landing X Slope (%)	N/A
<p>Surveyor Notes:</p> <p>N/A</p> <p>PROW/ADA:</p> <p>R304.2.2, R304.5.3</p>			N/A	Flare Type RT	N/A
			N/A	Flare Slope RT (%)	N/A
			N/A	Flare Traversable RT?	N/A
			N/A	DWS Provided?	N/A
			N/A	DWS Contrast?	N/A
			N/A	DWS Length (in)	N/A
			N/A	DWS Full Width?	N/A
			N/A	DWS Offset (in)	N/A
			N/A	Gutter Ponding?	N/A
			N/A	Gutter Lip Ht (in)	N/A
<p>Total Cost:</p> <p>\$ 1850.00</p>			Yes	Painted X Walk1?	N/A
				X Walk 1 Direction	To S
			N/A	X Walk 1 Width (in)	112.5
				X Walk 1 Slope (%)	1.3

X Walk 1 X Slope (%)	4.0
			N/A	Ramp inside XWalk1?	Yes
			N/A	Road Slope (%)	N/A
			N/A	Road X Slope (%)	N/A
			N/A	Any Obstructions?	N/A
				Obstruction Type	
			N/A	Clear Space?	N/A
			N/A	Clear Space to XWalk (in)	N/A
			N/A	Storm Grate/Utility Hazard?	N/A
				Storm Grate/Utility Type	
			N/A		N/A
			Yes	Surface Condition? (G/P)	Good
