Access Compliance Report

Public Rights-of-Way

(Curb Ramps)

Intersection ID: 31813	Main Street: WENDOVER_HILL_CT	Cross Street: CHURCHILL_RD	Location: NE
ADA ID: 7A70F00D5CF1	Ramp Type: BlendTrans2	Initial Pass/Fail: Fail	Overall Compliance: No
		Severity Score: 8.75

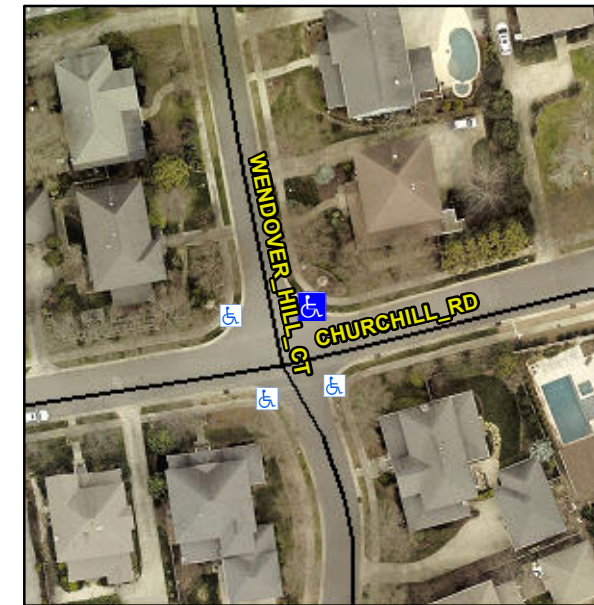
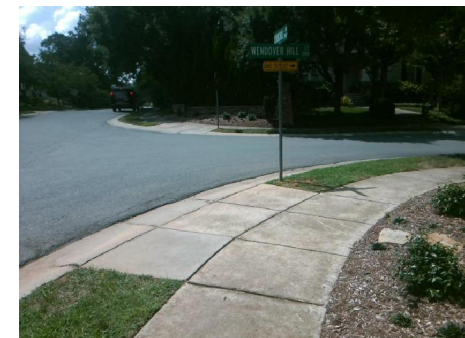
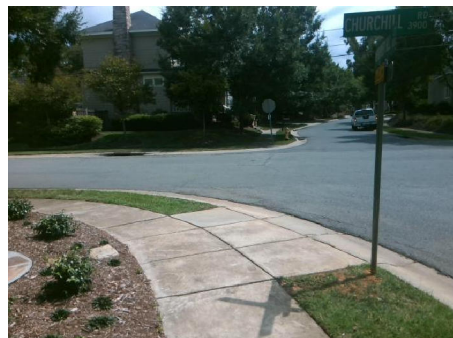
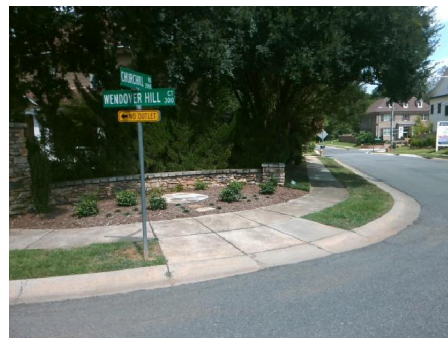
ASP LIP 1.0

Not Found, R304.5.1

Compliance	Description	Data	Compliance	Description	Data
N/A	Ramp Length (in)	97.0	Yes	BlendTrans Slope (%)	3.6
No	Ramp Width (in)	37.0	Yes	BlendTrans XSlope (%)	1.7
N/A	Flare Type LT	N/A	N/A	Flare Type RT	N/A
N/A	Flare Slope LT (%)	N/A	N/A	Flare Slope RT (%)	N/A
N/A	Flare Traversable LT?	N/A	N/A	Flare Traversable RT?	N/A
N/A	Landing Length (in)	N/A	N/A	DWS Provided?	N/A
N/A	Landing Width (in)	N/A	N/A	DWS Contrast?	N/A
N/A	Landing Slope (%)	N/A	N/A	DWS Length (in)	N/A
N/A	Landing X Slope (%)	N/A	N/A	DWS Full Width?	N/A
N/A	Landing Curb? (Y/N)	N/A	N/A	DWS Offset (in)	N/A
N/A	Shared Landing?	N/A			
N/A	Gutter Ponding?	N/A	N/A	Gutter Slope (%)	N/A
N/A	Gutter Lip Ht (in)	N/A	N/A	Gutter X Slope (%)	N/A
N/A	Painted X Walk1?	No	N/A	Painted X Walk2?	No
	X Walk 1 Direction	To W		X Walk 2 Direction	To S
	X Walk 1 Width (in)	N/A		X Walk 2 Width (in)	N/A
	X Walk 1 Slope (%)	1.8		X Walk 2 Slope (%)	2.5
	X Walk 1 X Slope (%)	3.2		X Walk 2 X Slope (%)	4.2

N/A	Ramp inside XWalk1?	N/A	N/A	Ramp inside XWalk2?	N/A
	Road Slope (%)	0.3		Clear Space?	N/A
	Road X Slope (%)	5.9	N/A	Clear Space to XWalk (in)	N/A
N/A	Any Obstructions?	N/A	N/A	Storm Grate/Utility Hazard?	N/A
	Obstruction Type			Storm Grate/Utility Type	
		N/A			N/A
			Yes	Surface Condition? (G/P)	Good
			No	Curb Slope (%)	12.3

Possible Solutions:

Remove & Replace Curb Ramp With Two New Directional Ramps or Equivalent.
