Access Compliance Report Public Rights-of-Way (Curb Ramps)

Intersection ID: 14714 Main Street: E MOREHEAD ST Cross Street: HARDING PL Location:

ADA ID: 7A79145DF77E Ramp Type: PerpDiag Initial Pass/Fail: Fail **Overall Compliance: No Severity Score:** 12.5

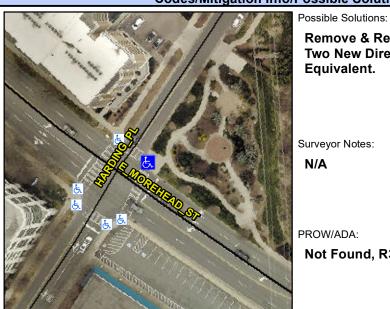
Not Found, R304.2.2

Field Measurements/Component Compilance					
Compliance Description		Data	Compliance Description		Data
N/A	Ramp Length (in)	59.0	No	Ramp Slope (%)	8.5
Yes	Ramp Width (in)	48.0	Yes	Ramp XSlope (%)	1.5
N/A	Flare Type LT	N/A	N/A	Flare Type RT	N/A
N/A	Flare Slope LT (%)	N/A	N/A	Flare Slope RT (%)	N/A
N/A	Flare Traversable LT?	N/A	N/A	Flare Traversable RT?	N/A
N/A	Landing Length (in)	N/A	N/A	DWS Provided?	N/A
N/A	Landing Width (in)	N/A	N/A	DWS Contrast?	N/A
N/A	Landing Slope (%)	N/A	N/A	DWS Length (in)	N/A
N/A	Landing X Slope (%)	N/A	N/A	DWS Full Width?	N/A
N/A	Landing Curb? (Y/N)	N/A	N/A	DWS Offset (in)	N/A
N/A	Shared Landing?	N/A			
N/A	Gutter Ponding?	N/A	N/A	Gutter Slope (%)	N/A
N/A	Gutter Lip Ht (in)	N/A	N/A	Gutter X Slope (%)	N/A
N/A	Painted X Walk1?	Yes	N/A	Painted X Walk2?	Yes
	X Walk 1 Direction	To NW		X Walk 2 Direction	To SW
N/A	X Walk 1 Width (in)	112.0	N/A	X Walk 2 Width (in)	105.0
	X Walk 1 Slope (%)	3.7		X Walk 2 Slope (%)	3.5

X Walk 1 X Slope (%)	1.2		X Walk 2 X Slope (%)	2.6
N/A	Ramp inside XWalk1?	Yes	N/A	Ramp inside XWalk2?	Yes
	Road Slope (%)	1.1	N/A	Clear Space?	N/A
	Road X Slope (%)	6.6	N/A	Clear Space to XWalk (in)	N/A
N/A	Any Obstructions?	N/A	N/A	Storm Grate/Utility Hazard?	N/A
	Obstruction Type			Storm Grate/Utility Type	
		N/A			N/A
			Yes	Surface Condition? (G/P)	Good

Remove & Replace Curb Ramp With Two New Directional Ramps or Equivalent.
