Intersection ID: 4199		Main Street: OLD_STATESVILLE_RD		Cross Street: W_W_T_HARRIS_BV		Location:		SE											
ADA ID: 7A8EA1205540		Ramp Type: Perp		Initial Pass/Fail: Fail		Overall Compliance: No		Severity Score: 12.5											
Codes/Mitigation Info/Possible Solution				Field Measurements/Component Compliance

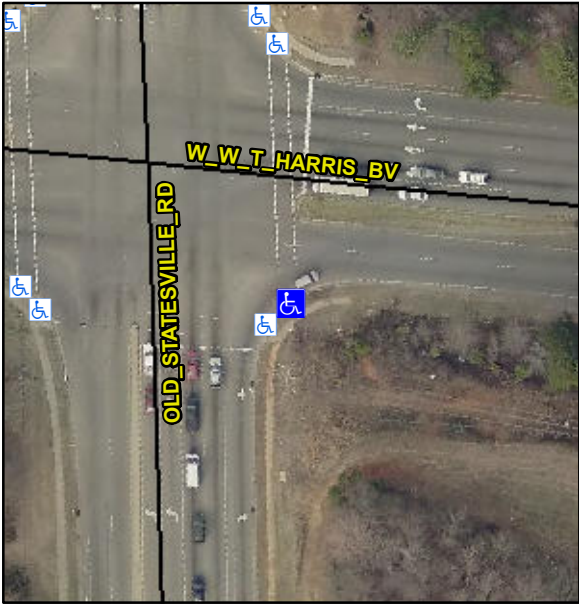
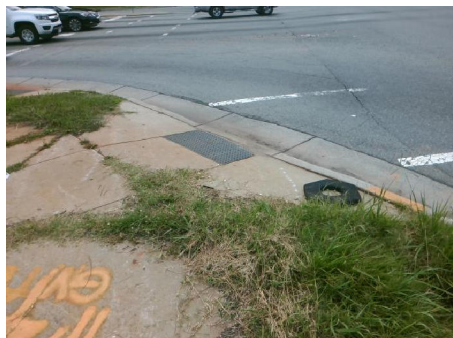
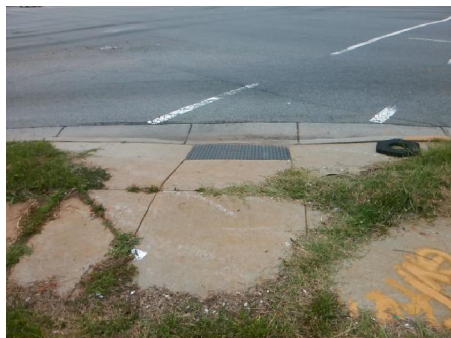
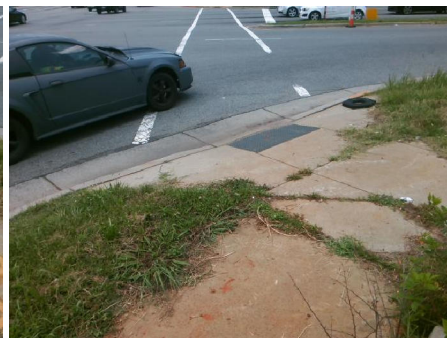
N/A		Landing Length (in)		N/A		N/A		DWS Provided?		N/A			
						N/A		Landing Width (in)		N/A		N/A		DWS Contrast?		N/A			
						N/A		Landing Slope (%)		N/A		N/A		DWS Length (in)		N/A			
						N/A		Landing X Slope (%)		N/A		N/A		DWS Full Width?		N/A			
<div>Surveyor Notes:</div> <div>N/A</div> <div>PROW/ADA:</div> <div>Not Found, R304.2.2</div>				N/A		Landing Curb? (Y/N)		N/A		N/A		DWS Offset (in)		N/A					
				N/A		Shared Landing?		N/A											
				N/A		Gutter Ponding?		N/A		N/A		Gutter Slope (%)		N/A					
				N/A		Gutter Lip Ht (in)		N/A		N/A		Gutter X Slope (%)		N/A					
				N/A		Painted X Walk1?		Yes		N/A		Painted X Walk2?		N/A					
						X Walk 1 Direction		To N				X Walk 2 Direction		N/A					
				N/A		X Walk 1 Width (in)		98.0		N/A		X Walk 2 Width (in)		N/A					
						X Walk 1 Slope (%)		2.4				X Walk 2 Slope (%)		N/A					
						X Walk 1 X Slope (%)		0.3				X Walk 2 X Slope (%)		N/A

<div>Street 1 Name<div>W W T HARRIS BV</div></div> <div>Stop Condition-Street 2<div>Signal</div></div> <div>Street 2 Name<div>N/A</div></div> <div>Stop Condition-Street 1<div>N/A</div></div>				Possible Solutions:		Compliance		Description		Data		Compliance		Description		Data			
				Remove & Replace Entire Ramp.		N/A		Ramp Length (in)		59.0		No		Ramp Slope (%)		11.1			
						Yes		Ramp Width (in)		48.0		Yes		Ramp XSlope (%)		1.0			
						N/A		Flare Type LT		N/A		N/A		Flare Type RT		N/A			
						N/A		Flare Slope LT (%)		N/A		N/A		Flare Slope RT (%)		N/A			
						N/A		Flare Traversable LT?		N/A		N/A		Flare Traversable RT?		N/A

N/A		Ramp inside XWalk1?		Yes		N/A		Ramp inside XWalk2?		N/A					
<div>Total Cost:</div> <div>\$ 1850.00</div>				Road Slope (%)		N/A		N/A		Clear Space?		N/A							
				Road X Slope (%)		N/A		N/A		Clear Space to XWalk (in)		N/A							
				N/A		Any Obstructions?		N/A		N/A		Storm Grate/Utility Hazard?		N/A					
						Obstruction Type						Storm Grate/Utility Type							
								N/A						N/A					
								Yes		Surface Condition? (G/P)		Good
