Access Compliance Report

Public Rights-of-Way

(Curb Ramps)

Intersection ID: 14147	Main Street: CHERRY_ST	Cross Street: LUTHER_ST	Location: SE
ADA ID: 7A8FABF949C6	Ramp Type: PerpDiag	Initial Pass/Fail: Fail	Overall Compliance: No
		Severity Score: 10

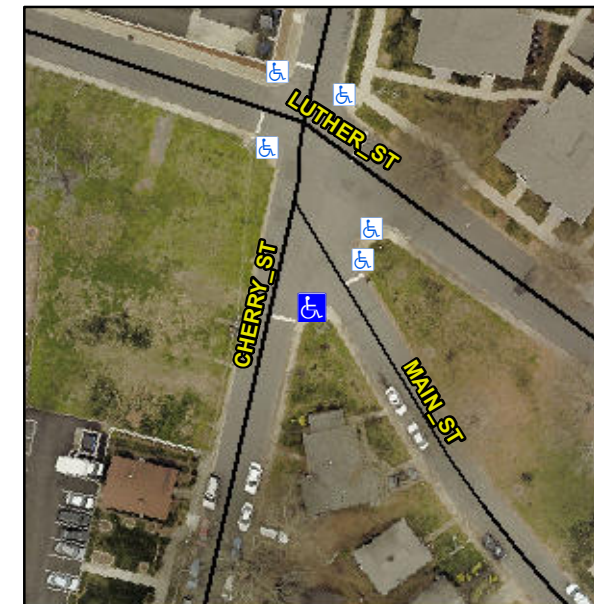
Compliance	Description	Data	Compliance	Description	Data
N/A	Ramp Length (in)	72.5	Yes	Ramp Slope (%)	5.3
No	Ramp Width (in)	47.0	No	Ramp XSlope (%)	3.6
N/A	Flare Type LT	N/A	N/A	Flare Type RT	N/A
N/A	Flare Slope LT (%)	N/A	N/A	Flare Slope RT (%)	N/A
N/A	Flare Traversable LT?	N/A	N/A	Flare Traversable RT?	N/A
N/A	Landing Length (in)	N/A	N/A	DWS Provided?	N/A
N/A	Landing Width (in)	N/A	N/A	DWS Contrast?	N/A
N/A	Landing Slope (%)	N/A	N/A	DWS Length (in)	N/A
N/A	Landing X Slope (%)	N/A	N/A	DWS Full Width?	N/A
N/A	Landing Curb? (Y/N)	N/A	N/A	DWS Offset (in)	N/A
N/A	Shared Landing?	N/A			
N/A	Gutter Ponding?	N/A	N/A	Gutter Slope (%)	N/A
N/A	Gutter Lip Ht (in)	N/A	N/A	Gutter X Slope (%)	N/A
N/A	Painted X Walk1?	No	N/A	Painted X Walk2?	No
	X Walk 1 Direction	To NE		X Walk 2 Direction	To NW
N/A	X Walk 1 Width (in)	N/A	N/A	X Walk 2 Width (in)	N/A
	X Walk 1 Slope (%)	3.5		X Walk 2 Slope (%)	0.3
	X Walk 1 X Slope (%)	3.2		X Walk 2 X Slope (%)	0.1

N/A	Ramp inside XWalk1?	N/A	N/A	Ramp inside XWalk2?	N/A
	Road Slope (%)	4.4	N/A	Clear Space?	N/A
	Road X Slope (%)	1.2	N/A	Clear Space to XWalk (in)	N/A
N/A	Any Obstructions?	N/A	N/A	Storm Grate/Utility Hazard?	N/A
	Obstruction Type			Storm Grate/Utility Type	
		N/A			N/A
		Yes		Surface Condition? (G/P)	Good

Remove & Replace Curb Ramp With Two New Directional Ramps or Equivalent.

R304.5.1, R304.5.3
