Access Compliance Report Public Rights-of-Way (Curb Ramps)

Intersection ID: 21086 Main Street: EASTBURN RD **Cross Street: SHARON RD** Location: N ADA ID: 7A923793E1A0 Ramp Type: PerpDiag Initial Pass/Fail: Fail **Overall Compliance: No Severity Score:** 12.5

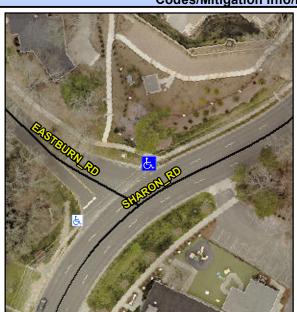
105.0 No

Not Found, R304.2.2

Yes	Ramp Width (in)	48.0	Yes	Ramp XSlope (%)	1.8
N/A	Flare Type LT	N/A	N/A	Flare Type RT	N/A
N/A	Flare Slope LT (%)	N/A	N/A	Flare Slope RT (%)	N/A
N/A	Flare Traversable LT?	N/A	N/A	Flare Traversable RT?	N/A
N/A	Landing Length (in)	N/A	N/A	DWS Provided?	N/A
N/A	Landing Width (in)	N/A	N/A	DWS Contrast?	N/A
N/A	Landing Slope (%)	N/A	N/A	DWS Length (in)	N/A
N/A	Landing X Slope (%)	N/A	N/A	DWS Full Width?	N/A
N/A	Landing Curb? (Y/N)	N/A	N/A	DWS Offset (in)	N/A
N/A	Shared Landing?	N/A			
N/A	Gutter Ponding?	N/A	N/A	Gutter Slope (%)	N/A
N/A	Gutter Lip Ht (in)	N/A	N/A	Gutter X Slope (%)	N/A
N/A	Painted X Walk1?	No	N/A	Painted X Walk2?	No
	X Walk 1 Direction	To SW		X Walk 2 Direction	To SE
N/A	X Walk 1 Width (in)	N/A	N/A	X Walk 2 Width (in)	N/A
	X Walk 1 Slope (%)	3.0		X Walk 2 Slope (%)	7.5
	X Walk 1 X Slope (%)	7.4		X Walk 2 X Slope (%)	3.7
N/A	Ramp inside XWalk1?	N/A	N/A	Ramp inside XWalk2?	N/A
	Road Slope (%)	3.0	N/A	Clear Space?	N/A

Road X Slope (%)	8.1	N/A	Clear Space to XWalk (in)	N/A
N/A	Any Obstructions?	N/A	N/A	Storm Grate/Utility Hazard?	N/A
	Obstruction Type			Storm Grate/Utility Type	
		N/A			N/A
			I

StopSign **SHARON RD** Remove & Replace Curb Ramp With Two New Directional Ramps or Equivalent.
