# Access Compliance Report

## Public Rights-of-Way

### (Curb Ramps)

Intersection ID: 43353	Main Street: PROSPERITY RIDGE RD	Cross Street: PROSPERITY COMMONS DR	Location: E
ADA ID: 7A9E84D2B7B5	Ramp Type: PerpDiag	Initial Pass/Fail: Fail	Overall Compliance: No
		Severity Score: 10

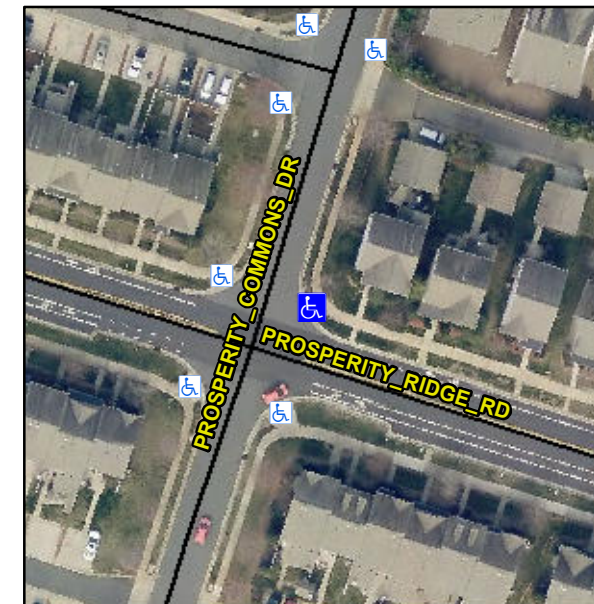
Compliance	Description	Data	Compliance	Description	Data
N/A	Ramp Length (in)	65.0	Yes	Ramp Slope (%)	7.6
No	Ramp Width (in)	40.0	No	Ramp XSlope (%)	2.6
N/A	Flare Type LT	N/A	N/A	Flare Type RT	N/A
N/A	Flare Slope LT (%)	N/A	N/A	Flare Slope RT (%)	N/A
N/A	Flare Traversable LT?	N/A	N/A	Flare Traversable RT?	N/A
N/A	Landing Length (in)	N/A	N/A	DWS Provided?	N/A
N/A	Landing Width (in)	N/A	N/A	DWS Contrast?	N/A
N/A	Landing Slope (%)	N/A	N/A	DWS Length (in)	N/A
N/A	Landing X Slope (%)	N/A	N/A	DWS Full Width?	N/A
N/A	Landing Curb? (Y/N)	N/A	N/A	DWS Offset (in)	N/A
N/A	Shared Landing?	N/A			
N/A	Gutter Ponding?	N/A	N/A	Gutter Slope (%)	N/A
N/A	Gutter Lip Ht (in)	N/A	N/A	Gutter X Slope (%)	N/A
N/A	Painted X Walk1?	No	N/A	Painted X Walk2?	No
	X Walk 1 Direction	To NW		X Walk 2 Direction	To SW
N/A	X Walk 1 Width (in)	N/A	N/A	X Walk 2 Width (in)	N/A
	X Walk 1 Slope (%)	0.8		X Walk 2 Slope (%)	2.2
	X Walk 1 X Slope (%)	2.1		X Walk 2 X Slope (%)	0.6

N/A	Ramp inside XWalk1?	N/A	N/A	Ramp inside XWalk2?	N/A
	Road Slope (%)	1.3	N/A	Clear Space?	N/A
	Road X Slope (%)	3.7	N/A	Clear Space to XWalk (in)	N/A
N/A	Any Obstructions?	N/A	N/A	Storm Grate/Utility Hazard?	N/A
	Obstruction Type			Storm Grate/Utility Type	
		N/A			N/A
			Yes	Surface Condition? (G/P)	Good

**Remove & Replace Curb Ramp With Two New Directional Ramps or Equivalent.**

**R304.5.1, R304.5.3**
