# Access Compliance Report

## Public Rights-of-Way

### (Curb Ramps)

Intersection ID: 50511	Main Street: ALLEN_A_BROWN_RD	Cross Street: MERIDALE_CROSSING_DR	Location: E
ADA ID: 7AB511ACBFF7	Ramp Type: PerpDiag	Initial Pass/Fail: Fail	Overall Compliance: No
Severity Score: 0			
Codes/Mitigation Info/Possible Solution		Field Measurements/Component Compliance

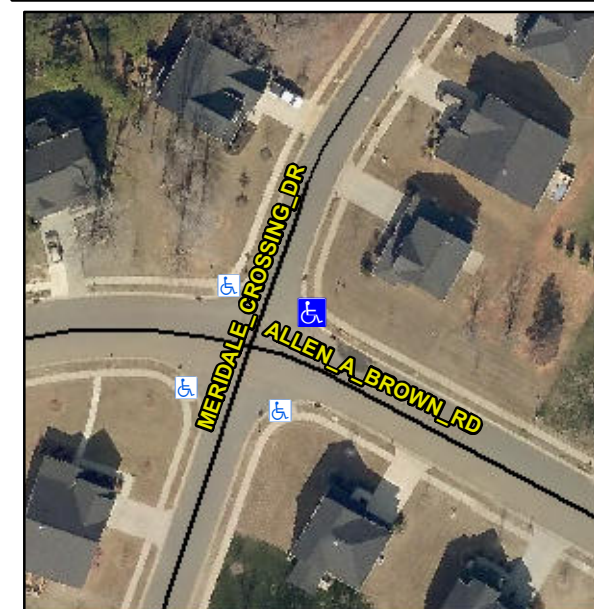
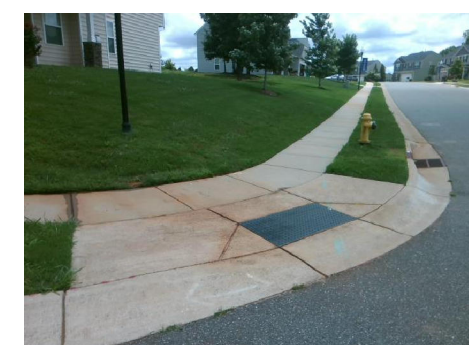
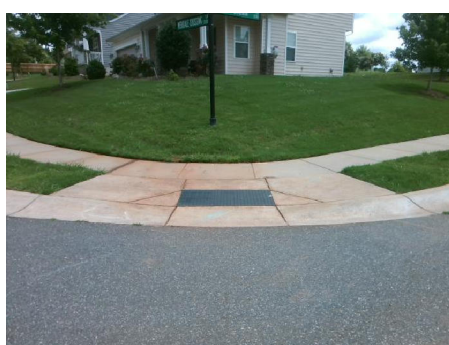
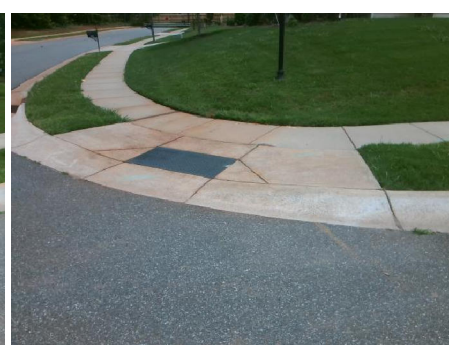
Compliance	Description	Data	Compliance	Description	Data
N/A	Ramp Length (in)	48.0	Yes	Ramp Slope (%)	5.9
Yes	Ramp Width (in)	48.0	Yes	Ramp XSlope (%)	0.1
N/A	Flare Type LT	N/A	N/A	Flare Type RT	N/A
N/A	Flare Slope LT (%)	N/A	N/A	Flare Slope RT (%)	N/A
N/A	Flare Traversable LT?	N/A	N/A	Flare Traversable RT?	N/A
N/A	Landing Length (in)	N/A	N/A	DWS Provided?	N/A
N/A	Landing Width (in)	N/A	N/A	DWS Contrast?	N/A
N/A	Landing Slope (%)	N/A	N/A	DWS Length (in)	N/A
N/A	Landing X Slope (%)	N/A	N/A	DWS Full Width?	N/A
N/A	Landing Curb? (Y/N)	N/A	N/A	DWS Offset (in)	N/A
N/A	Shared Landing?	N/A			
N/A	Gutter Ponding?	N/A	N/A	Gutter Slope (%)	N/A
N/A	Gutter Lip Ht (in)	N/A	N/A	Gutter X Slope (%)	N/A
N/A	Painted X Walk1?	No	N/A	Painted X Walk2?	No
	X Walk 1 Direction	To NW		X Walk 2 Direction	To SW
N/A	X Walk 1 Width (in)	N/A	N/A	X Walk 2 Width (in)	N/A
	X Walk 1 Slope (%)	1.5		X Walk 2 Slope (%)	0.7
	X Walk 1 X Slope (%)	0.9		X Walk 2 X Slope (%)	2.0

N/A	Ramp inside XWalk1?	N/A	N/A	Ramp inside XWalk2?	N/A
	Road Slope (%)	0.3	N/A	Clear Space?	N/A
	Road X Slope (%)	1.1	N/A	Clear Space to XWalk (in)	N/A
N/A	Any Obstructions?	N/A	N/A	Storm Grate/Utility Hazard?	N/A
	Obstruction Type			Storm Grate/Utility Type	
		N/A			N/A
		Yes		Surface Condition? (G/P)	Good

Possible Solutions:

**Remove & Replace Curb Ramp With Two New Directional Ramps or Equivalent.**
