# Access Compliance Report

## Public Rights-of-Way

| Intersection ID: 32273 | Main Street: GREYMORE_CT | Cross Street: PRESCOTT_HILL_AV | Location: SW |
| ADA ID: 7ABC06DC3CDE | Ramp Type: PerpDiag | Initial Pass/Fail: Fail | Overall Compliance: No |

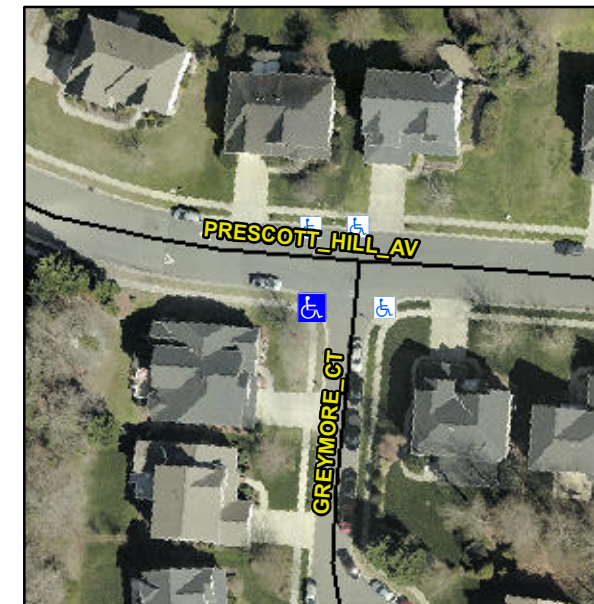
**Not Found, R304.5.1, R304.5.3**

| Compliance | Description | Data | Compliance | Description | Data |
|---|---|---|---|---|---|
| N/A | Ramp Length (in) | 65.0 | Yes | Ramp Slope (%) | 8.1 |
| No | Ramp Width (in) | 39.0 | No | Ramp XSlope (%) | 5.4 |

**Remove & Replace Curb Ramp With Two New Directional Ramps or Equivalent.**

Total Cost: \$ 3200.00
