# Access Compliance Report

## Public Rights-of-Way

| Intersection ID: 54325 | Main Street: CANTERBURY CASTLE DR | Cross Street: ROCKY HILL CASTLE DR | Location: NE |
| ADA ID: 7AC18F2038A7 | Ramp Type: Perp | Initial Pass/Fail: Fail | Overall Compliance: No |

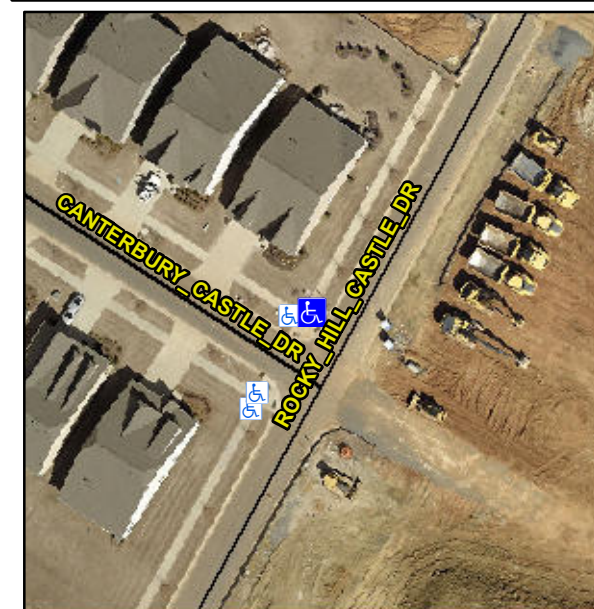
| Severity Score: 21.25 | | | |

**Not Found, R304.5.1, R304.2.2**

| Compliance | Description | Data | Compliance | Description | Data |
|---|---|---|---|---|---|
| N/A | Ramp Length (in) | 114.0 | No | Ramp Slope (%) | 11.4 |
| No | Ramp Width (in) | 45.5 | Yes | Ramp XSlope (%) | 0.6 |

**Remove & Replace Entire Ramp.**

Total Cost: \$ 1850.00
