Access Compliance Report

Public Rights-of-Way

(Curb Ramps)

Intersection ID: 24540	Main Street: BIRNEN_DR	Cross Street: CAMERON_WOOD_DR	Location:	N
ADA ID: 7AC5EB2691D6	Ramp Type: PerpDiag	Initial Pass/Fail: Fail	Overall Compliance: No	Severity Score: 22.5

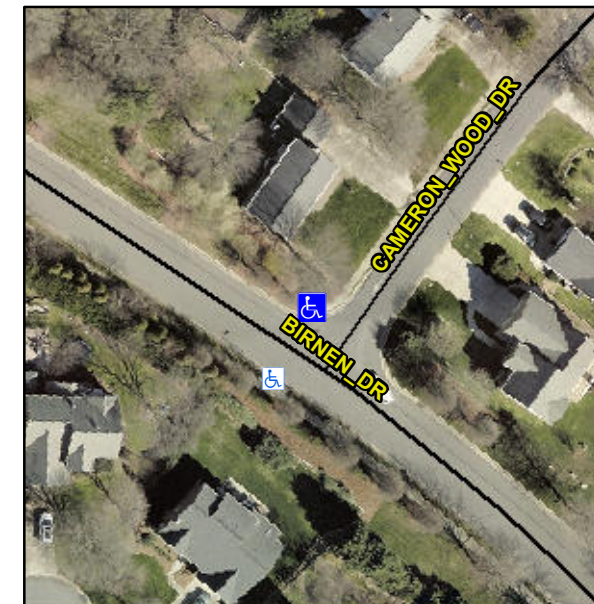
Not Found, R304.5.1, R304.2.2, R304.5.3

Compliance	Description	Data	Compliance	Description	Data
N/A	Ramp Length (in)	61.0	No	Ramp Slope (%)	9.5
No	Ramp Width (in)	39.5	No	Ramp XSlope (%)	4.7
N/A	Flare Type LT	N/A	N/A	Flare Type RT	N/A
N/A	Flare Slope LT (%)	N/A	N/A	Flare Slope RT (%)	N/A
N/A	Flare Traversable LT?	N/A	N/A	Flare Traversable RT?	N/A
N/A	Landing Length (in)	N/A	N/A	DWS Provided?	N/A
N/A	Landing Width (in)	N/A	N/A	DWS Contrast?	N/A
N/A	Landing Slope (%)	N/A	N/A	DWS Length (in)	N/A
N/A	Landing X Slope (%)	N/A	N/A	DWS Full Width?	N/A
N/A	Landing Curb? (Y/N)	N/A	N/A	DWS Offset (in)	N/A
N/A	Shared Landing?	N/A			
N/A	Gutter Ponding?	N/A	N/A	Gutter Slope (%)	N/A
N/A	Gutter Lip Ht (in)	N/A	N/A	Gutter X Slope (%)	N/A
N/A	Painted X Walk1?	No	N/A	Painted X Walk2?	No
	X Walk 1 Direction	To SW		X Walk 2 Direction	To SE
N/A	X Walk 1 Width (in)	N/A	N/A	X Walk 2 Width (in)	N/A
	X Walk 1 Slope (%)	6.4		X Walk 2 Slope (%)	1.9
	X Walk 1 X Slope (%)	1.3		X Walk 2 X Slope (%)	3.4

N/A	Ramp inside XWalk1?	N/A	N/A	Ramp inside XWalk2?	N/A
	Road Slope (%)	3.2	N/A	Clear Space?	N/A
	Road X Slope (%)	4.5	N/A	Clear Space to XWalk (in)	N/A
N/A	Any Obstructions?	N/A	N/A	Storm Grate/Utility Hazard?	N/A
	Obstruction Type			Storm Grate/Utility Type	
		N/A			N/A
			Yes	Surface Condition? (G/P)	Good

Remove & Replace Curb Ramp With Two New Directional Ramps or Equivalent.
