Access Compliance Report Public Rights-of-Way (Curb Ramps)

Intersection ID: 28082 Main Str	Main Street: THREE_LAKES_DR		cross Street: WARWICK_LINKS_DR				Location:		
ADA ID: 7AC6EB865382 Ramp Ty	/pe: PerpDiag	Initial Pass	itial Pass/Fail: Pass Overall Compliance				o Severity Score:	22.75	
Codes/Mitigation Info/Possible Solution			Field Measurements/Component Compliance						
the second secon	Possible Solutions:	Co	Compliance Description			Data Compliance Description			
	Remove & Replace Curb Ramp W	ith N//	A Ramp Le	ength (in)	48.0	Yes	Ramp Slope (%)	7.6	
	Two New Directional Ramps or Equivalent. Remove & Replace Gutter.	Ye	s Ramp W	/idth (in)	64.0	No	Ramp XSlope (%)	2.2	
		N/#	Flare Ty	pe LT	Sloped	N/A	Flare Type RT	N/A	
		N//	A Flare Sl	ope LT (%)	0.0	Yes	Flare Slope RT (%)	1.3	
		N//	A Flare Tra	aversable LT?	Yes	N/A	Flare Traversable RT?	Yes	
		No	Landing	Length (in)	40.0	No	DWS Provided?	No	
	Surveyor Notes:	Ye	s Landing	Width (in)	64.0	N/A	DWS Contrast?	No

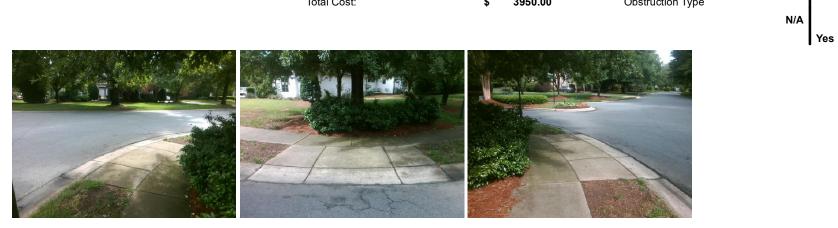
N/A	Ye	s Landing	Slope (%)	2.0	N/A	DWS Length (in)	N/A	
		Ye	s Landing	X Slope (%)	1.6	N/A	DWS Full Width?	No	
		N//	A Landing	Curb? (Y/N)	No	N/A	DWS Offset (in)	N/A	
		N//	A Shared I	Landing?	No				
	PROW/ADA:	Ye	s Gutter F	onding?	No	No	Gutter Slope (%)	5.1	
	Not Found, R304.5.3, R304.2.1,	No	Gutter L	ip Ht (in)	0.5	Yes	Gutter X Slope (%)	1.2	
	R305, R302.7.2, R304.5.4	N//	A Painted	X Walk1?	No	N/A	Painted X Walk2?	No	
Constant of the			X Walk ?	1 Direction	To NE		X Walk 2 Direction	To NW	
		N//	A X Walk ²	1 Width (in)	N/A	N/A	X Walk 2 Width (in)	N/A	
Street 1 Name THREE LAKES DR			X Walk ²	1 Slope (%)	2.4		X Walk 2 Slope (%)	2.3	
Stop Condition-Street 2 None			X Walk ?	1 X Slope (%)	2.8		X Walk 2 X Slope (%)	0.3	
Street 2 Name WARWICK LINKS DR		N//	A Ramp in	side XWalk1?	N/A	N/A	Ramp inside XWalk2?	N/A	
Stop Condition-Street 1 StopSign			Road Sl	ope (%)	0.4	N/A	Clear Space?	Yes	
			Road X	Slope (%)	4.1	N/A	Clear Space to XWalk (in)	N/A

Ye	s Any Obs	structions?	No	Yes	Storm Grate/Utility Hazard?	No	
	Total Cost: \$ 39	50.00	Obstruc	tion Type			Storm Grate/Utility Type		
					N/A			N/A

s Surface Condition? (G/P) Good
