# Access Compliance Report

## Public Rights-of-Way

### (Curb Ramps)

Intersection ID: 50602	Main Street: RHODORA_RD	Cross Street: CEDARFIELD_RD	Location: SW
ADA ID: 7AD2BF9744B2	Ramp Type: Perp	Initial Pass/Fail: Fail	Overall Compliance: No
Severity Score: 35			
Codes/Mitigation Info/Possible Solution		Field Measurements/Component Compliance

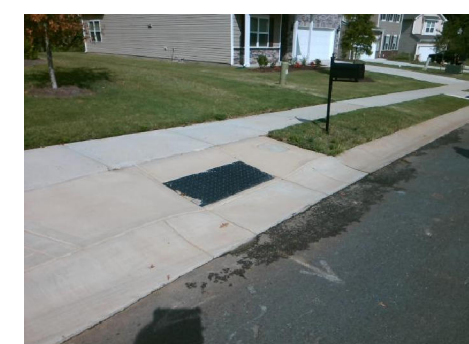
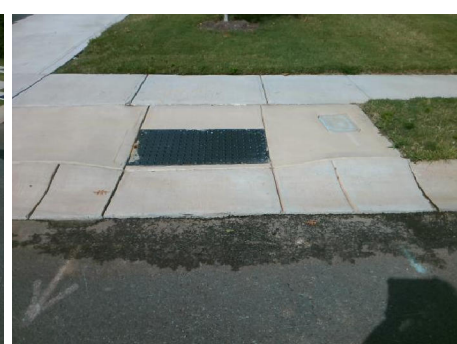
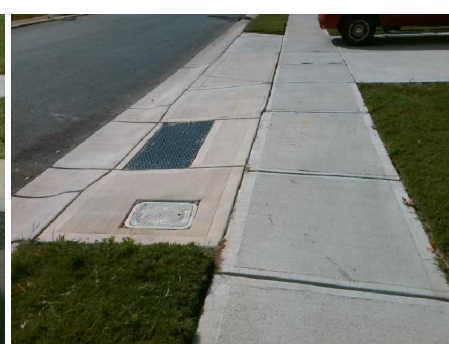
**Not Found, R304.5.1, R304.2.2**

Compliance	Description	Data	Compliance	Description	Data
N/A	Ramp Length (in)	47.5	No	Ramp Slope (%)	14.4
No	Ramp Width (in)	47.0	Yes	Ramp XSlope (%)	3.2
N/A	Flare Type LT	N/A	N/A	Flare Type RT	N/A
N/A	Flare Slope LT (%)	N/A	N/A	Flare Slope RT (%)	N/A
N/A	Flare Traversable LT?	N/A	N/A	Flare Traversable RT?	N/A
N/A	Landing Length (in)	N/A	N/A	DWS Provided?	N/A
N/A	Landing Width (in)	N/A	N/A	DWS Contrast?	N/A
N/A	Landing Slope (%)	N/A	N/A	DWS Length (in)	N/A
N/A	Landing X Slope (%)	N/A	N/A	DWS Full Width?	N/A
N/A	Landing Curb? (Y/N)	N/A	N/A	DWS Offset (in)	N/A
N/A	Shared Landing?	N/A			
N/A	Gutter Ponding?	N/A	N/A	Gutter Slope (%)	N/A
N/A	Gutter Lip Ht (in)	N/A	N/A	Gutter X Slope (%)	N/A
N/A	Painted X Walk1?	No	N/A	Painted X Walk2?	N/A
	X Walk 1 Direction	To E		X Walk 2 Direction	N/A
N/A	X Walk 1 Width (in)	N/A	N/A	X Walk 2 Width (in)	N/A
	X Walk 1 Slope (%)	1.8		X Walk 2 Slope (%)	N/A
	X Walk 1 X Slope (%)	3.5		X Walk 2 X Slope (%)	N/A

N/A	Ramp inside XWalk1?	N/A	N/A	Ramp inside XWalk2?	N/A
	Road Slope (%)	N/A	N/A	Clear Space?	N/A
	Road X Slope (%)	N/A	N/A	Clear Space to XWalk (in)	N/A
N/A	Any Obstructions?	N/A	N/A	Storm Grate/Utility Hazard?	N/A
	Obstruction Type			Storm Grate/Utility Type	
		N/A			N/A
			Yes	Surface Condition? (G/P)	Good

**Remove & Replace Entire Ramp.**
