Access Compliance Report

Public Rights-of-Way

(Curb Ramps)

Intersection ID: 49102		Main Street: PROSPERITY_CROSSING_DR		Cross Street: BENFIELD_RD		Location: N											
ADA ID: 7AEEF49F6F38		Ramp Type: Directional1		Initial Pass/Fail: Pass		Overall Compliance: No		Severity Score: 5.25									
Codes/Mitigation Info/Possible Solution				Field Measurements/Component Compliance													
<div>

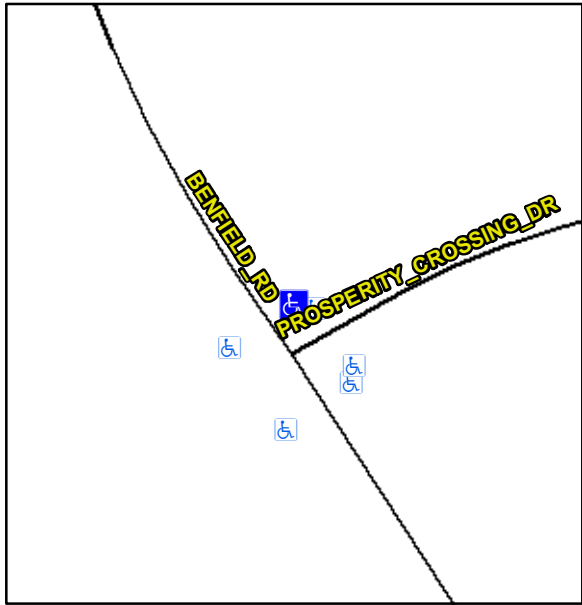
</div> <div>Street 1 NameBENFIELD RD</div> <div>Stop Condition-Street 1None</div> <div>Street 2 NameN/A</div> <div>Stop Condition-Street 2N/A</div>				Possible Solutions:		Compliance		Description		Data		Compliance		Description		Data	
				Remove & Replace Gutter.		N/A	Ramp Length (in)	69.0		Yes	Grade Break?	Yes					
						Yes	Ramp Width (in)	71.5		Yes	Grade Break Slope (%)	1.8					
						Yes	Ramp Slope (%)	1.2		Yes	Grade Break XSlope (%)	3.2					
						Yes	Ramp XSlope (%)	3.0									
						N/A	Flare Type LT	N/A		N/A	Flare Type RT	N/A					
						N/A	Flare Slope LT (%)	N/A		N/A	Flare Slope RT (%)	N/A

N/A	Flare Traversable LT?	N/A		N/A	Flare Traversable RT?	N/A					
						Yes	Landing Length (in)	71.0		Yes	DWS Provided?	Yes					
						Yes	Landing Width (in)	70.0		Yes	DWS Contrast?	Yes					
		Yes	Landing Slope (%)	0.2		Yes	DWS Length (in)	24.0									
		Yes	Landing X Slope (%)	1.7		Yes	DWS Full Width?	Yes									
		N/A	Landing Curb? (Y/N)	No		Yes	DWS Offset LT (in)	22.0									
		N/A	Shared Landing?	Yes		Yes	DWS Offset RT (in)	1.0									
		Yes	Gutter Ponding?	No		No	Gutter Slope (%)	5.3									
		Yes	Gutter Lip Ht (in)	0.0		Yes	Gutter X Slope (%)	3.7									
		N/A	Painted X Walk1?	No			Road Slope (%)	0.3									
			X Walk 1 Direction	To SW			Road X Slope (%)	3.7									
			X Walk 1 Width (in)	N/A			Clear Space?	Yes									
			X Walk 1 Slope (%)	0.3		N/A	Clear Space to XWalk (in)	N/A									
			X Walk 1 X Slope (%)	3.7		Yes	Storm Grate/Utility Hazard?	No									
		N/A	Ramp inside XWalk1?	N/A			Storm Grate/Utility Type

Yes	Any Obstructions?	No				N/A									
			Obstruction Type			Yes	Surface Condition? (G/P)	Good									
						N/A	Curb Slope (%)	1.3									
		Surveyor Notes:															
		N/A															
		PROW/ADA:															
		R304.5.4															
		Total Cost:		\$	750.00
