Access Compliance Report

Public Rights-of-Way

(Curb Ramps)

Intersection ID: 47613	Main Street: BATHURST_DR	Cross Street: MACQUARIE_LN	Location: SE
ADA ID: 7AF93CE8BF13	Ramp Type: PerpDiag	Initial Pass/Fail: Fail	Overall Compliance: No
		Severity Score: 10

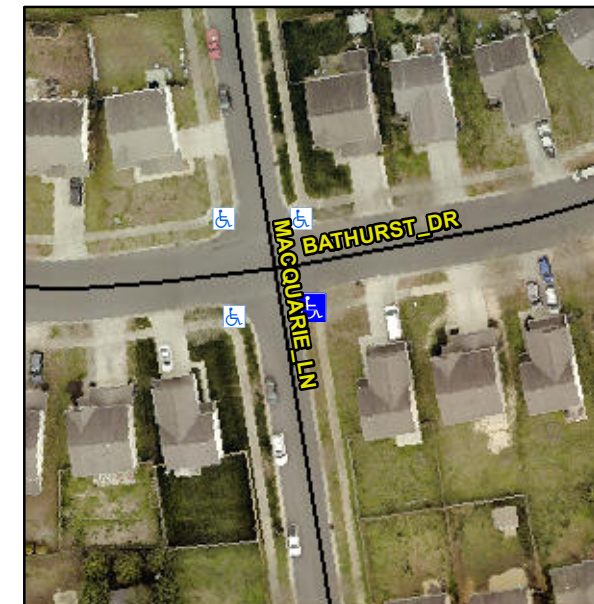
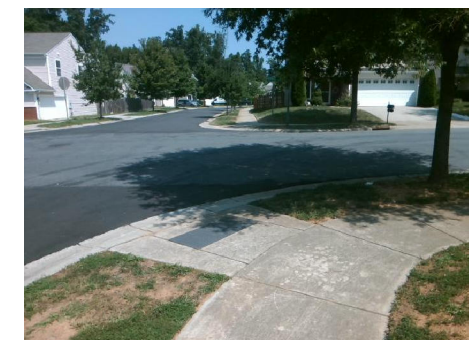
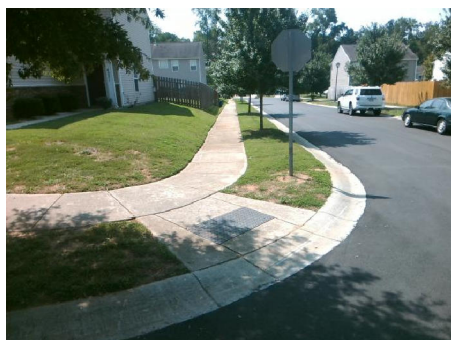
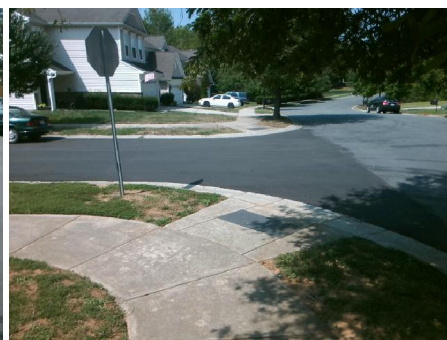
Compliance	Description	Data	Compliance	Description	Data
N/A	Ramp Length (in)	68.5	Yes	Ramp Slope (%)	7.2
No	Ramp Width (in)	46.0	No	Ramp XSlope (%)	2.1
N/A	Flare Type LT	N/A	N/A	Flare Type RT	N/A
N/A	Flare Slope LT (%)	N/A	N/A	Flare Slope RT (%)	N/A
N/A	Flare Traversable LT?	N/A	N/A	Flare Traversable RT?	N/A
N/A	Landing Length (in)	N/A	N/A	DWS Provided?	N/A
N/A	Landing Width (in)	N/A	N/A	DWS Contrast?	N/A
N/A	Landing Slope (%)	N/A	N/A	DWS Length (in)	N/A
N/A	Landing X Slope (%)	N/A	N/A	DWS Full Width?	N/A
N/A	Landing Curb? (Y/N)	N/A	N/A	DWS Offset (in)	N/A
N/A	Shared Landing?	N/A			
N/A	Gutter Ponding?	N/A	N/A	Gutter Slope (%)	N/A
N/A	Gutter Lip Ht (in)	N/A	N/A	Gutter X Slope (%)	N/A
N/A	Painted X Walk1?	No	N/A	Painted X Walk2?	No
	X Walk 1 Direction	To N		X Walk 2 Direction	To W
N/A	X Walk 1 Width (in)	N/A	N/A	X Walk 2 Width (in)	N/A
	X Walk 1 Slope (%)	5.4		X Walk 2 Slope (%)	1.5
	X Walk 1 X Slope (%)	2.0		X Walk 2 X Slope (%)	2.6

N/A	Ramp inside XWalk1?	N/A	N/A	Ramp inside XWalk2?	N/A
	Road Slope (%)	1.4	N/A	Clear Space?	N/A
	Road X Slope (%)	3.3	N/A	Clear Space to XWalk (in)	N/A
N/A	Any Obstructions?	N/A	N/A	Storm Grate/Utility Hazard?	N/A
	Obstruction Type			Storm Grate/Utility Type	
		N/A			N/A
			Yes	Surface Condition? (G/P)	Good

Remove & Replace Curb Ramp With Two New Directional Ramps or Equivalent.

Not Found, R304.5.1, R304.5.3
