Access Compliance Report

Public Rights-of-Way

(Curb Ramps)

| Intersection ID: 43869 | Main Street: CALDWELL RIDGE PY | Cross Street: SIDNEY CREST AV | Location: NE |

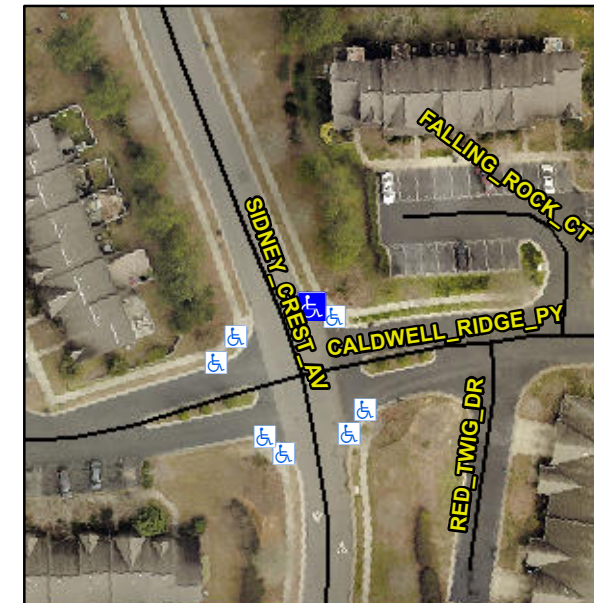
| ADA ID: 7AFA0E9BEFD5 | Ramp Type: Perp | Initial Pass/Fail: Fail | Overall Compliance: No |

Not Found, R304.5.1, R304.5.3

| Compliance | Description | Data | Compliance | Description | Data |
|---|---|---|---|---|---|
| N/A | Ramp Length (in) | 48.0 | Yes | Ramp Slope (%) | 7.7 |
| No | Ramp Width (in) | 40.0 | No | Ramp XSlope (%) | 8.2 |

Remove & Replace Entire Ramp.
