# Access Compliance Report

## Public Rights-of-Way

### (Curb Ramps)

Intersection ID: 3738	Main Street: SANDRINGHAM_PL	Cross Street: WITHERSHINN_DR	Location: SE
ADA ID: 7B023C89C598	Ramp Type: Perp	Initial Pass/Fail: Fail	Overall Compliance: No
Severity Score: 8.75			
Codes/Mitigation Info/Possible Solution		Field Measurements/Component Compliance

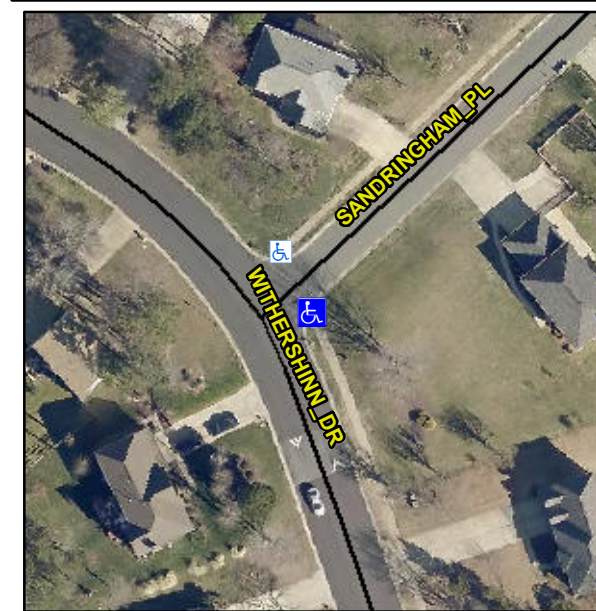
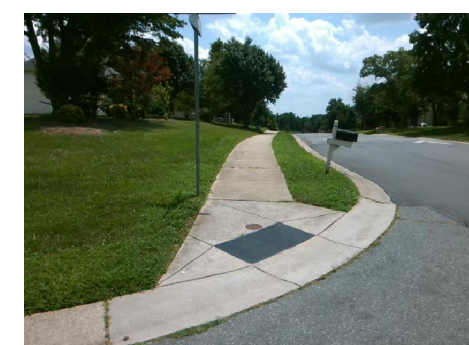
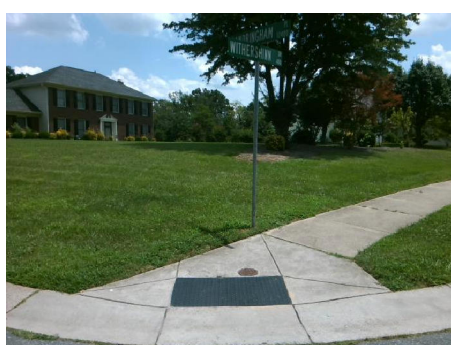
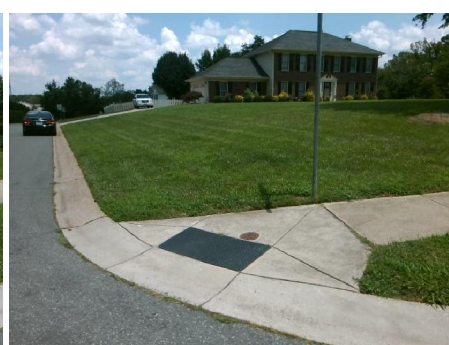
**Not Found, R304.5.1**

Compliance	Description	Data	Compliance	Description	Data
N/A	Ramp Length (in)	46.0	Yes	Ramp Slope (%)	7.8
No	Ramp Width (in)	47.5	Yes	Ramp XSlope (%)	1.0
N/A	Flare Type LT	N/A	N/A	Flare Type RT	N/A
N/A	Flare Slope LT (%)	N/A	N/A	Flare Slope RT (%)	N/A
N/A	Flare Traversable LT?	N/A	N/A	Flare Traversable RT?	N/A
N/A	Landing Length (in)	N/A	N/A	DWS Provided?	N/A
N/A	Landing Width (in)	N/A	N/A	DWS Contrast?	N/A
N/A	Landing Slope (%)	N/A	N/A	DWS Length (in)	N/A
N/A	Landing X Slope (%)	N/A	N/A	DWS Full Width?	N/A
N/A	Landing Curb? (Y/N)	N/A	N/A	DWS Offset (in)	N/A
N/A	Shared Landing?	N/A			
N/A	Gutter Ponding?	N/A	N/A	Gutter Slope (%)	N/A
N/A	Gutter Lip Ht (in)	N/A	N/A	Gutter X Slope (%)	N/A
N/A	Painted X Walk1?	No	N/A	Painted X Walk2?	N/A
	X Walk 1 Direction	To N		X Walk 2 Direction	N/A
N/A	X Walk 1 Width (in)	N/A	N/A	X Walk 2 Width (in)	N/A
	X Walk 1 Slope (%)	1.5		X Walk 2 Slope (%)	N/A
	X Walk 1 X Slope (%)	2.0		X Walk 2 X Slope (%)	N/A

N/A	Ramp inside XWalk1?	N/A	N/A	Ramp inside XWalk2?	N/A
	Road Slope (%)	N/A	N/A	Clear Space?	N/A
	Road X Slope (%)	N/A	N/A	Clear Space to XWalk (in)	N/A
N/A	Any Obstructions?	N/A	N/A	Storm Grate/Utility Hazard?	N/A
	Obstruction Type			Storm Grate/Utility Type	
		N/A			N/A
			Yes	Surface Condition? (G/P)	Good

**Remove & Replace Entire Ramp.**

Total Cost: \$ 1850.00
