Access Compliance Report

Public Rights-of-Way

(Curb Ramps)

Intersection ID: 9269	Main Street: BODKIN_CT	Cross Street: SPRINGHEAD_LN	Location: NW
ADA ID: 7B08CE942E25	Ramp Type: Perp	Initial Pass/Fail: Fail	Overall Compliance: No
Severity Score: 33.75			
Codes/Mitigation Info/Possible Solution		Field Measurements/Component Compliance

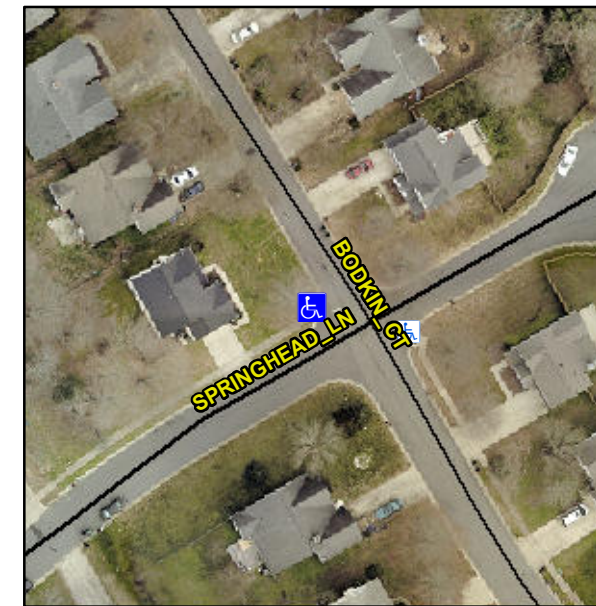
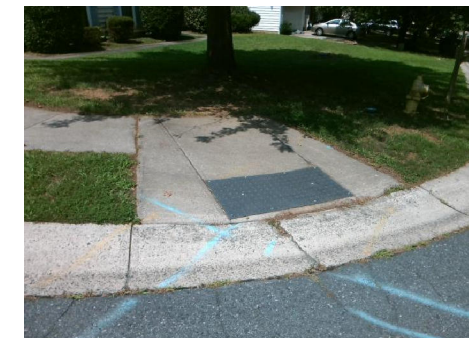
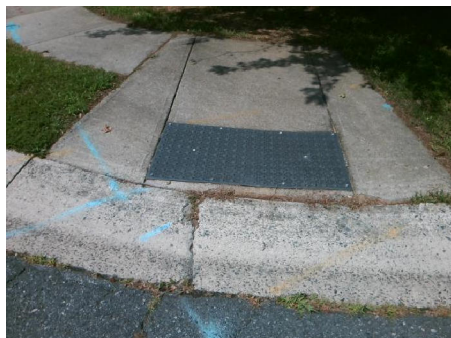
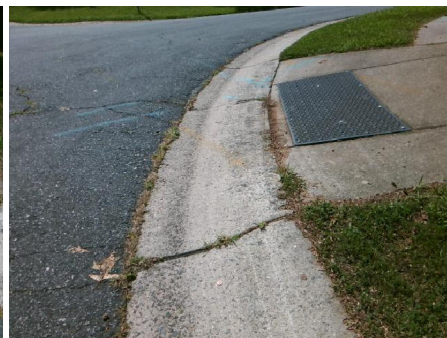
Not Found, R304.5.1, R304.5.3

Compliance	Description	Data	Compliance	Description	Data
N/A	Ramp Length (in)	53.0	Yes	Ramp Slope (%)	5.6
No	Ramp Width (in)	47.5	No	Ramp XSlope (%)	9.2
N/A	Flare Type LT	N/A	N/A	Flare Type RT	N/A
N/A	Flare Slope LT (%)	N/A	N/A	Flare Slope RT (%)	N/A
N/A	Flare Traversable LT?	N/A	N/A	Flare Traversable RT?	N/A
N/A	Landing Length (in)	N/A	N/A	DWS Provided?	N/A
N/A	Landing Width (in)	N/A	N/A	DWS Contrast?	N/A
N/A	Landing Slope (%)	N/A	N/A	DWS Length (in)	N/A
N/A	Landing X Slope (%)	N/A	N/A	DWS Full Width?	N/A
N/A	Landing Curb? (Y/N)	N/A	N/A	DWS Offset (in)	N/A
N/A	Shared Landing?	N/A			
N/A	Gutter Ponding?	N/A	N/A	Gutter Slope (%)	N/A
N/A	Gutter Lip Ht (in)	0.5	N/A	Gutter X Slope (%)	N/A
N/A	Painted X Walk1?	No	N/A	Painted X Walk2?	N/A
	X Walk 1 Direction	To NE		X Walk 2 Direction	N/A
N/A	X Walk 1 Width (in)	N/A	N/A	X Walk 2 Width (in)	N/A
	X Walk 1 Slope (%)	6.3		X Walk 2 Slope (%)	N/A
	X Walk 1 X Slope (%)	7.0		X Walk 2 X Slope (%)	N/A

N/A	Ramp inside XWalk1?	N/A	N/A	Ramp inside XWalk2?	N/A
	Road Slope (%)	N/A	N/A	Clear Space?	N/A
	Road X Slope (%)	N/A	N/A	Clear Space to XWalk (in)	N/A
N/A	Any Obstructions?	N/A	N/A	Storm Grate/Utility Hazard?	N/A
	Obstruction Type			Storm Grate/Utility Type	
		N/A			N/A
			Yes	Surface Condition? (G/P)	Good

Possible Solutions:

Remove & Replace Entire Ramp.
